PARKS AND OPEN SPACE & BUILDINGS AND FACILITIES						
Facility ID	Address	Inspector	Inspection	Maintenance Required?	Notes	Facility Maintenance
Athletic League Field (F-1)	COWELL LAND	Bob Lamoureux	4/28/2025	No		
Boy Scouts of America 132 (F-2)	24 SPRING ST	Bob Lamoureux	4/28/2025	Yes		Stone Chip Driveway: Repair erosion at driveway entrance
Council on Aging (F-3)	24 SPRING ST	Bob Lamoureux	4/28/2025	No		
Field of Dreams (F-4)	78 SCHOOL ST	Bob Lamoureux	4/28/2025	Yes		Stone chip driveway at catch basin: Reroute erosion around catch basin in-front of practice baseball field. Stone trench: Cut brush along trench
Former Police/Fire (F-5)	157 SOUTH ST	Bob Lamoureux	4/28/2025	Yes		Catch Basin and Access road: Clean debris around catch basin and sweep access roadway around building Access Road: Sweep access road around building

BMP #	Record Plan	Facility Name	Location	BMP/Feature Description	Inspection Date	Recommended Maintenance	Action Taken
BMP-1	No	Roadway Stormwater Management System	68 Messenger Street	BMP-1: Detention Basin	5/21/2025	None	
BMP-2	No	Roadway Stormwater Management System	2 Maple Terrace	BMP-2: Detention Basin	5/1/2025	None	
BMP-3	No	Roadway Stormwater Management Sys

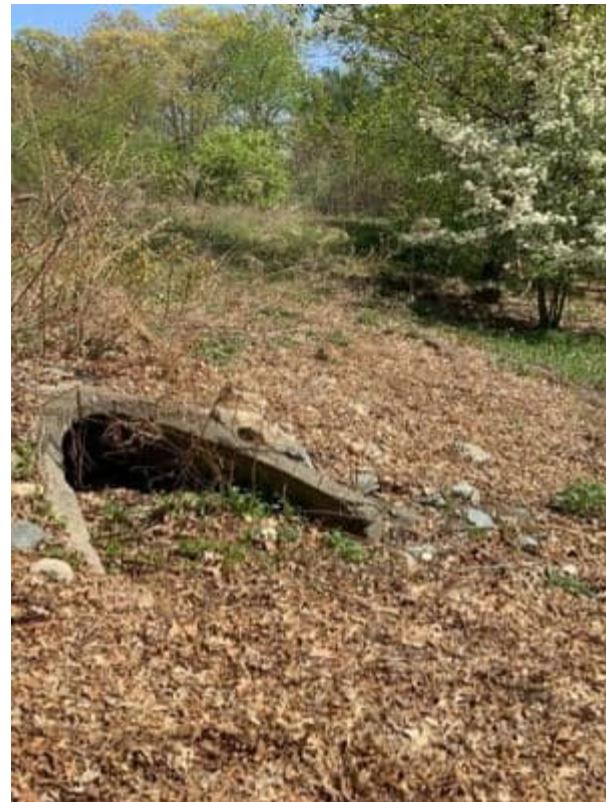
Basin inlet

Problem	Description	Quantity	Completed (by)	Date
Inlet	Remove yard waste from inlet			
Outlet	Remove leaves and debris from outlet control structure opening

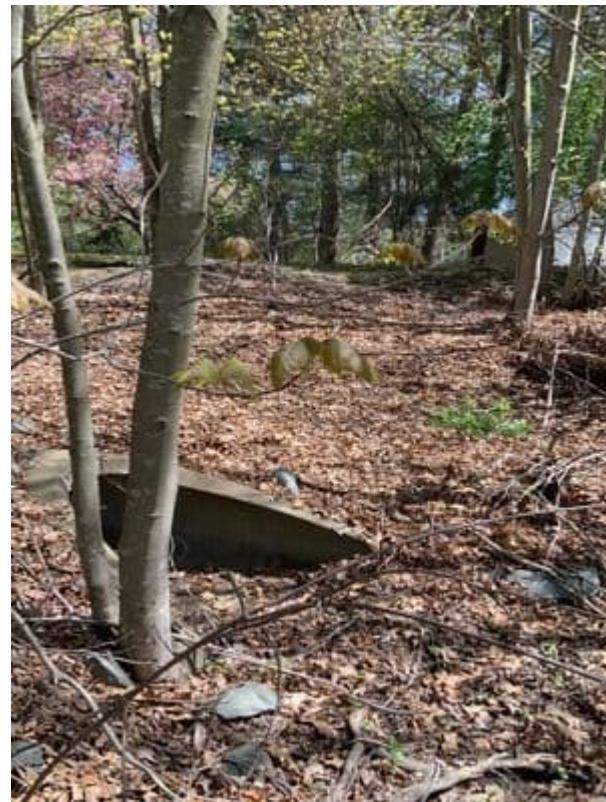
Basin inlet

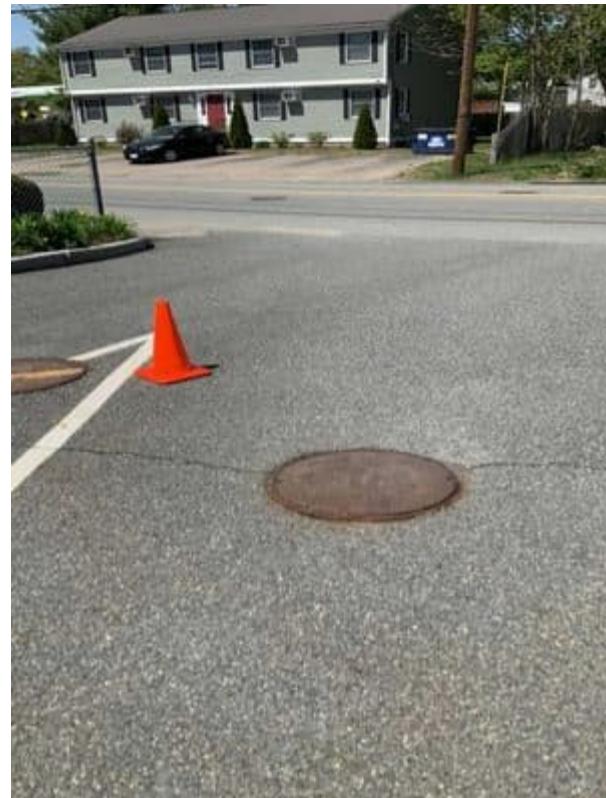
Outside 1st DMH CNO Rusted shut

Problem	Description	Quantity	Completed (by)	Date
Sediment/Debris	Remove sediment and debris to help water discharge			
Grate/Cover	Repair frame and grate

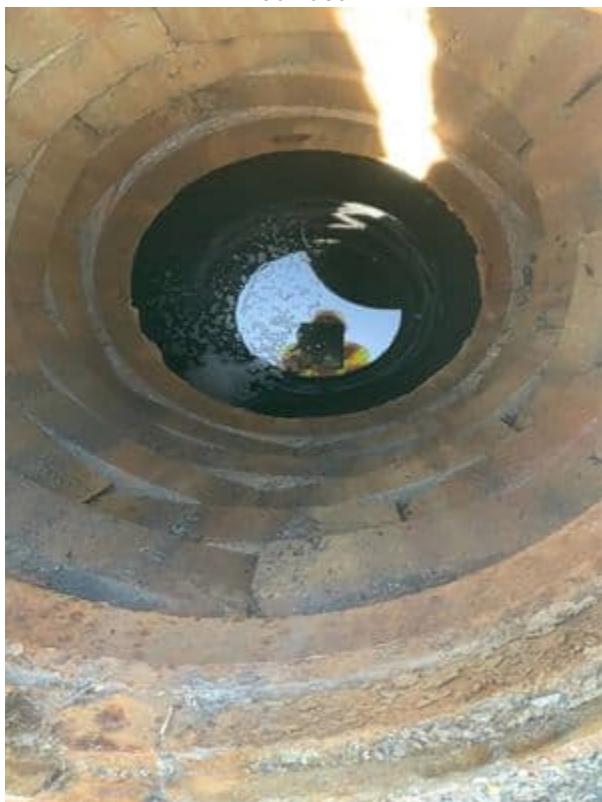
Inside 2nd DMH (standing water)

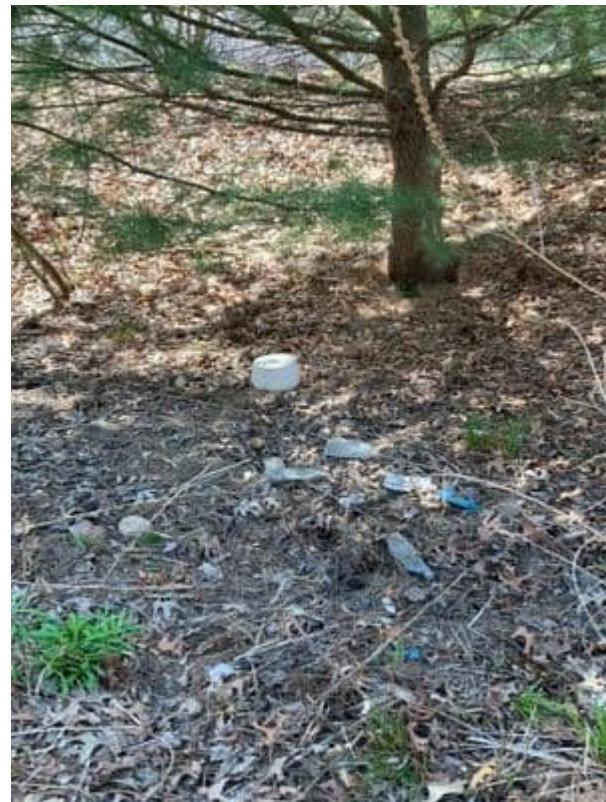
Trash in basin

Problem	Description	Quantity	Completed (by)	Date
Sediment/Debris	Remove trash

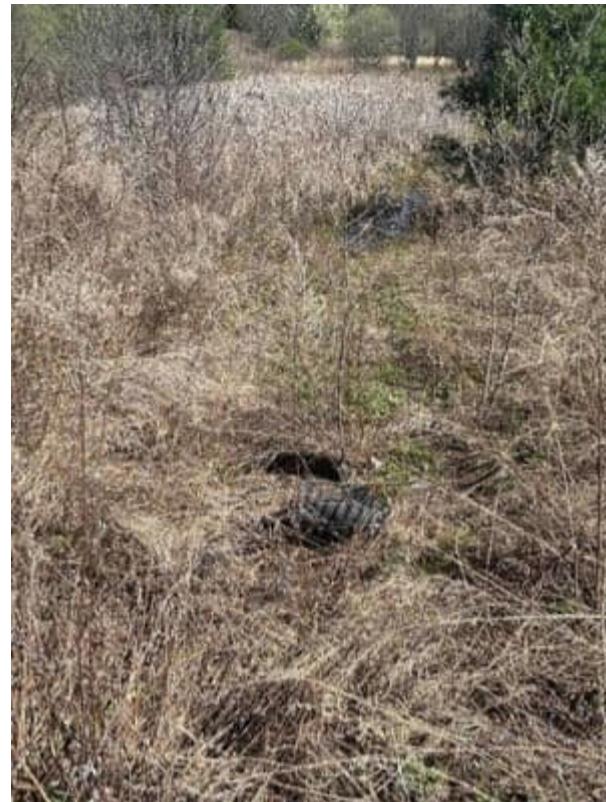
Basin inlet

Problem	Description	Quantity	Completed (by)	Date
	Clean brush and trees from basin and basin inlet

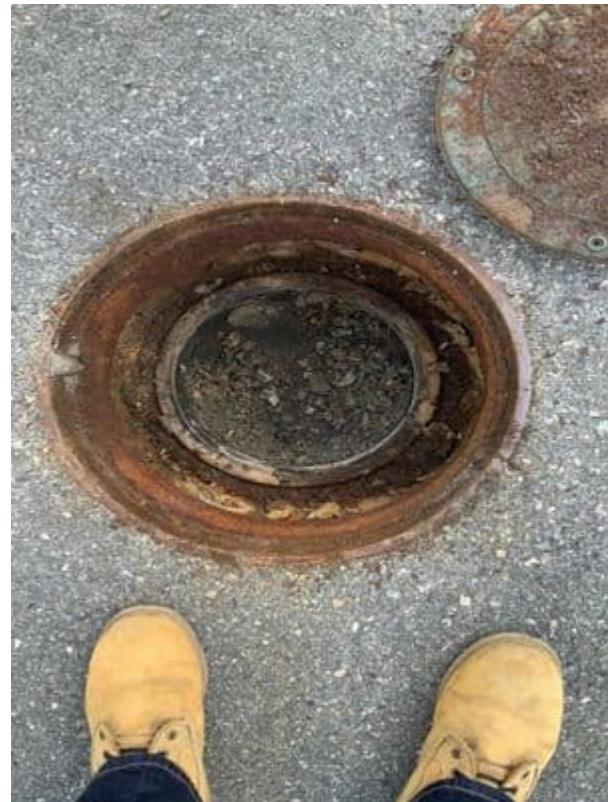
Interior of clean out at handicap parking space

Problem	Description	Quantity	Completed (by)	Date
Sediment/Debris	Remove Sediment and Debris

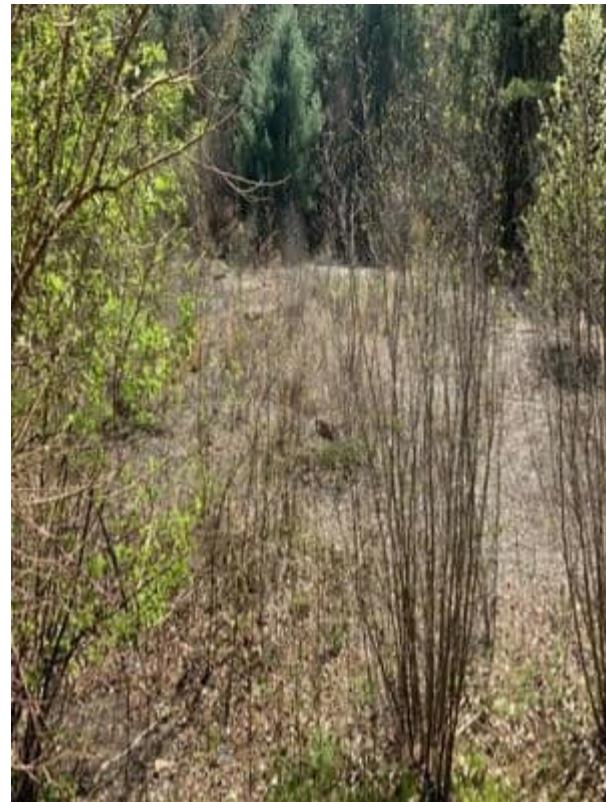
Detention basin with 4 leaching catch basins. Remove dead trees and brush

Problem	Description	Quantity	Completed (by)	Date
Riprap	Clean up trash and overgrowth of vegetation			
Other	Remove dead trees and brush from main basin area			
Sediment/Debris	Remove sediment, debris, and trash from all catch basins

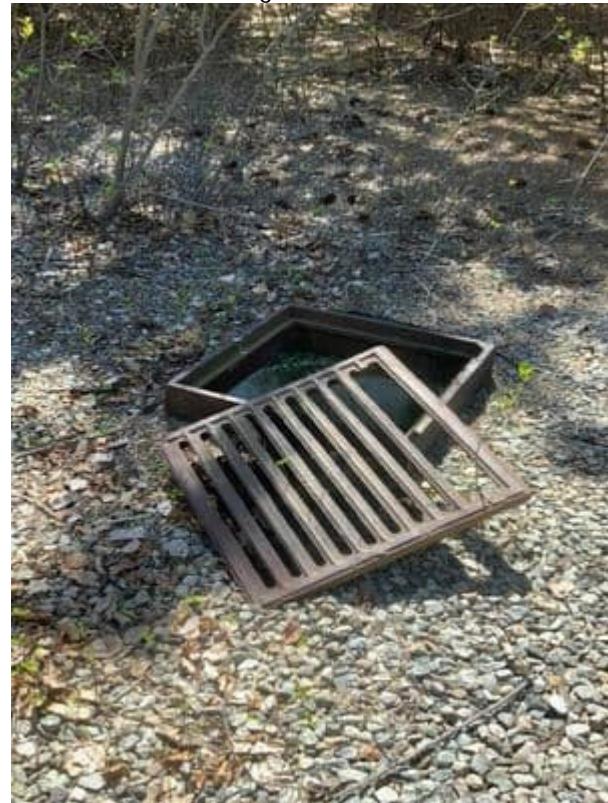
Leaching Catch Basin #4 Cover has been removed and broken. Trash inside catch basin

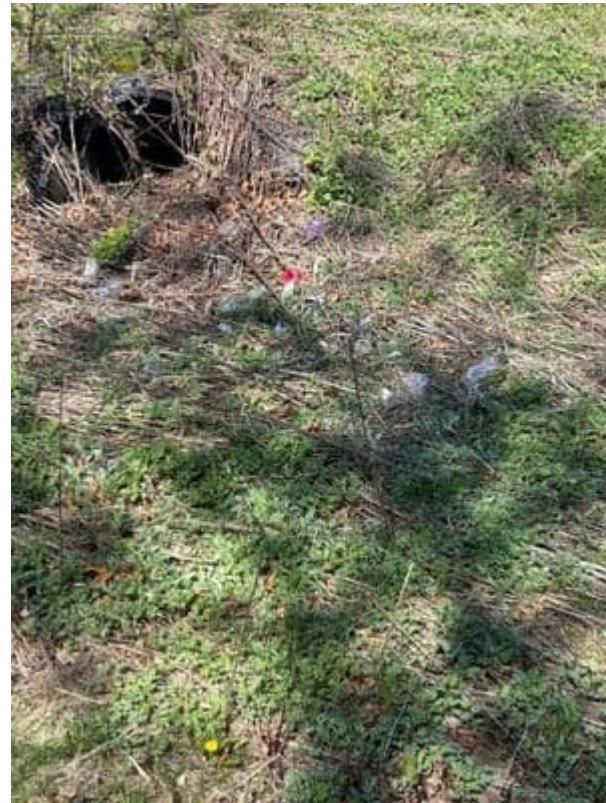
Trash at basin inlet

Problem	Description	Quantity	Completed (by)	Date
Outlet	Remove trees and brush blocking outlet structure opening			
Inlet	Remove brush and trash at basin inlet

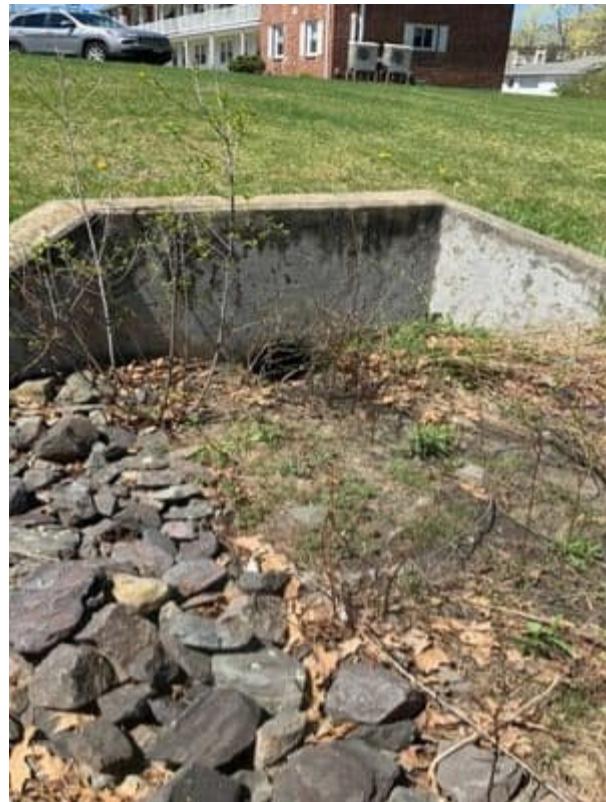
Debris at inlet pipe

Problem	Description	Quantity	Completed (by)	Date
Sediment/Debris	Remove sediment and minor yard debris at inlet			
Riprap	Extend riprap to wooded area to avoid erosion

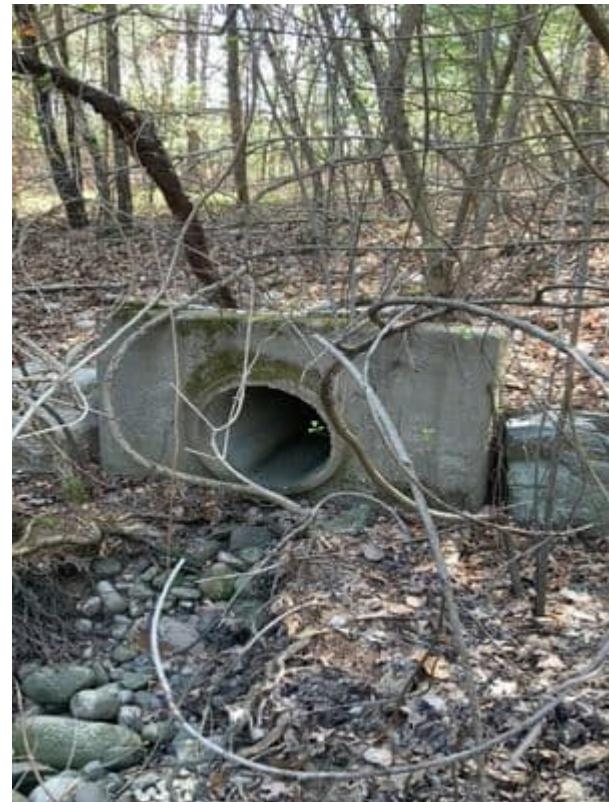
Stormwater Outfall #2 from Tanglewood Road. Unable to locate possibly removed

Problem	Description	Quantity	Completed (by)	Date
Inlet	Remove trash and pet waste from outfalls	-		
Sediment/Debris	Remove trash, leaves, and debris throughout basin

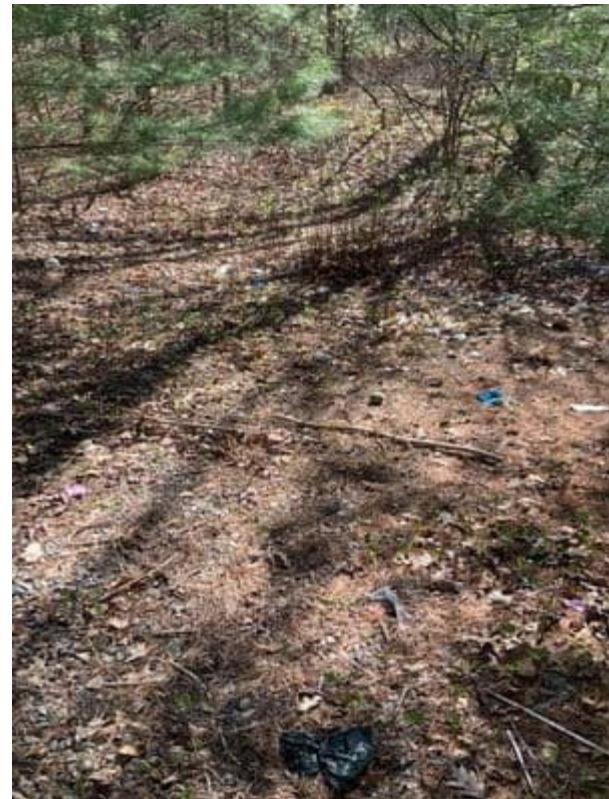
Trash and debris in basin

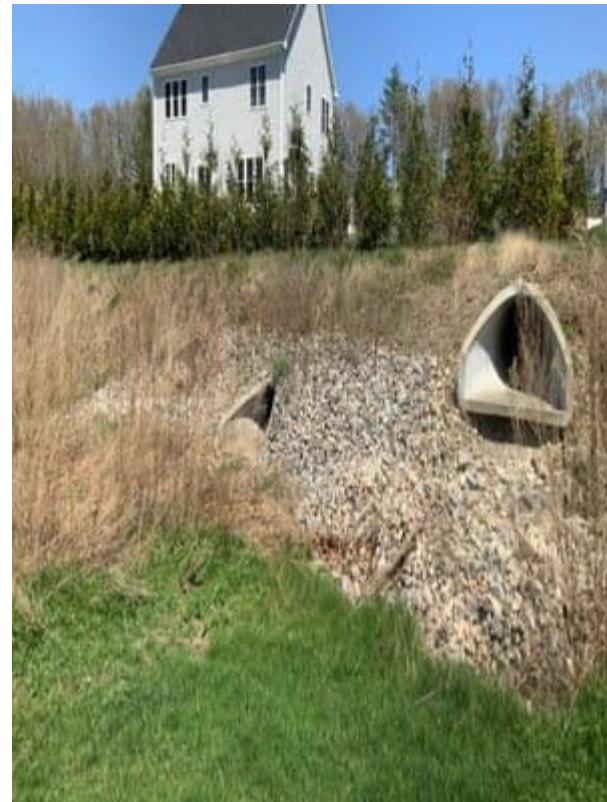
Three basin inlets to detention basin

Problem	Description	Quantity	Completed (by)	Date
Erosion	Erosion at 30" outfall. Add rip rap

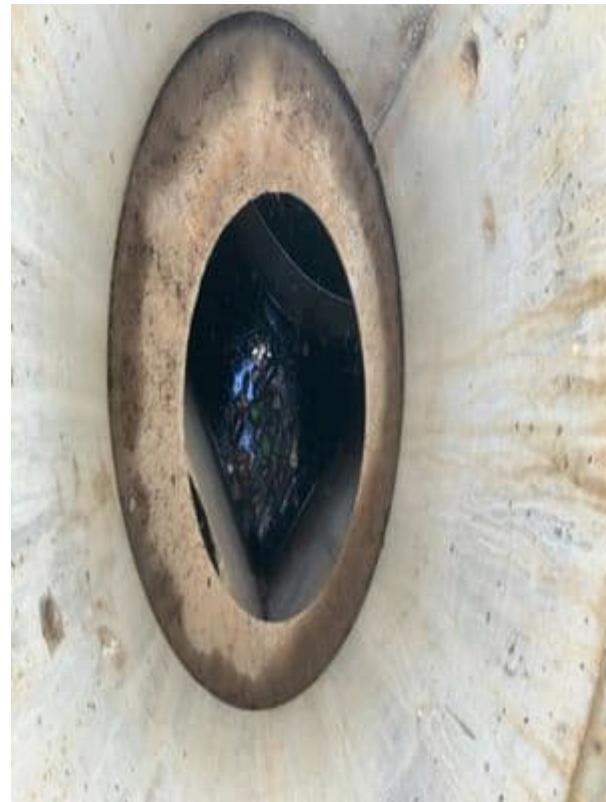
Trash middle mh

Problem	Description	Quantity	Completed (by)	Date
Sediment/Debris	Remove trash and debris	1

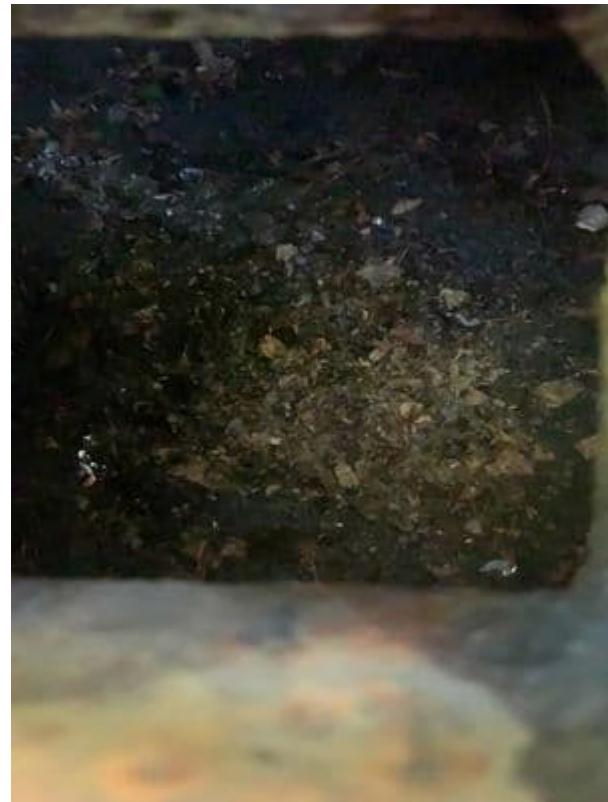
Inside Leaching catch basin

Problem	Description	Quantity	Completed (by)	Date
Grate/Cover	Remove leaves and debris from grate and remove sediment and debris from catch basin interior

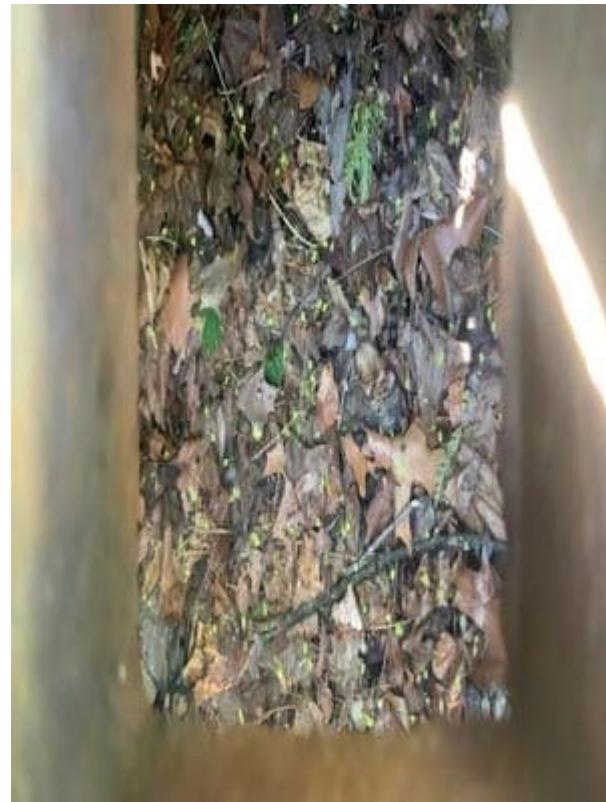
Clean catch basin interior

Problem	Description	Quantity	Completed (by)	Date
Sediment/Debris	Remove sediment and leaves from grate and interior	1 ft of sediment

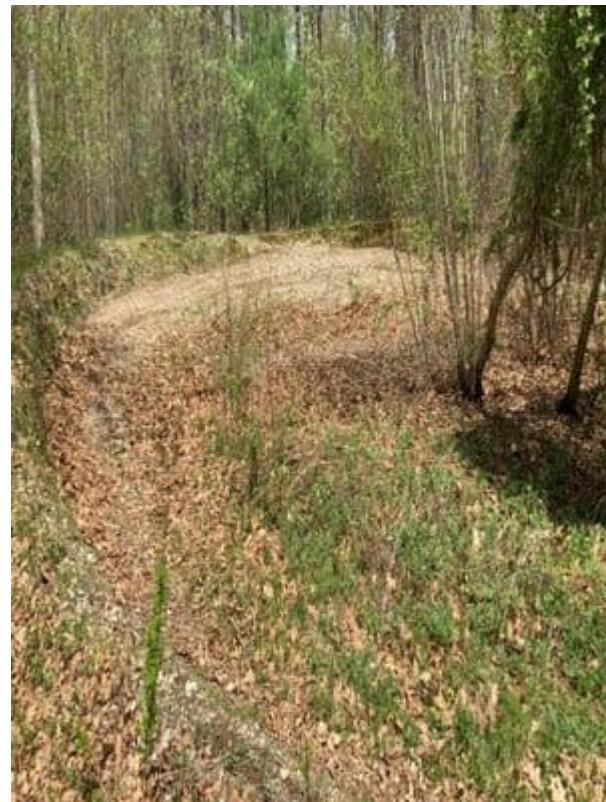
Erosion on embankment from motorcycles
