PARKS AND OPEN SPACE & BUILDINGS AND FACILITIES						
Facility ID	Address	Inspector	Inspection	Maintenance Required?	Notes	Facility Maintenance
Athletic League Field (F-1)	COWELL LAND	Bob Lamoureux	4/28/2025	No		
Boy Scouts of America 132 (F-2)	24 SPRING ST	Bob Lamoureux	4/28/2025	Yes		Stone Chip Driveway: Repair erosion at driveway entrance
Council on Aging (F-3)	24 SPRING ST	Bob Lamoureux	4/28/2025	No		
Field of Dreams (F-4)	78 SCHOOL ST	Bob Lamoureux	4/28/2025	Yes		Stone chip driveway at catch basin: Reroute erosion around catch basin in-front of practice baseball field. Stone trench: Cut brush along trench
Former Police/Fire (F-5)	157 SOUTH ST	Bob Lamoureux	4/28/2025	Yes		Catch Basin and Access road: Clean debris around catch basin and sweep access roadway around building Access Road: Sweep access road around building

BMP #	Record Plan	Facility Name	Location	BMP/Feature Description	Inspection Date	Recommended Maintenance	Action Taken
BMP-1	No	Roadway Stormwater Management System	68 Messenger Street	BMP-1: Detention Basin	5/21/2025	None	
BMP-2	No	Roadway Stormwater Management System	2 Maple Terrace	BMP-2: Detention Basin	5/1/2025	None	
BMP-3	No	Roadway Stormwater Management Sys

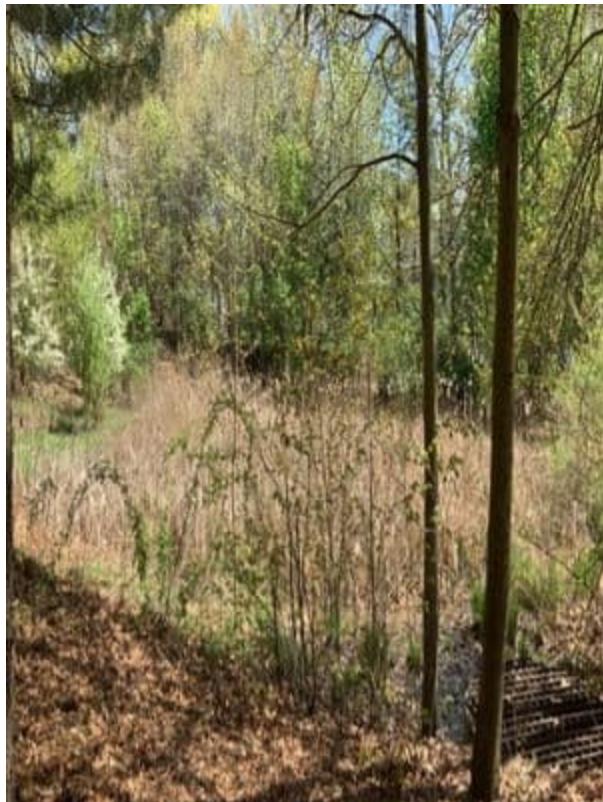
Basin

Problem	Description	Quantity	Completed (by)	Date
Inlet	Remove yard waste from inlet			
Outlet	Remove leaves and debris from outlet control structure opening

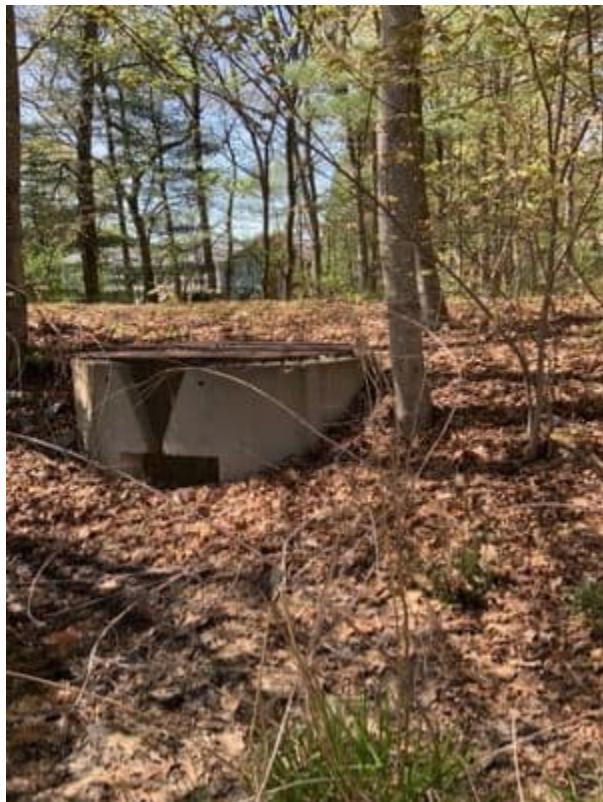
Basin outlet structure

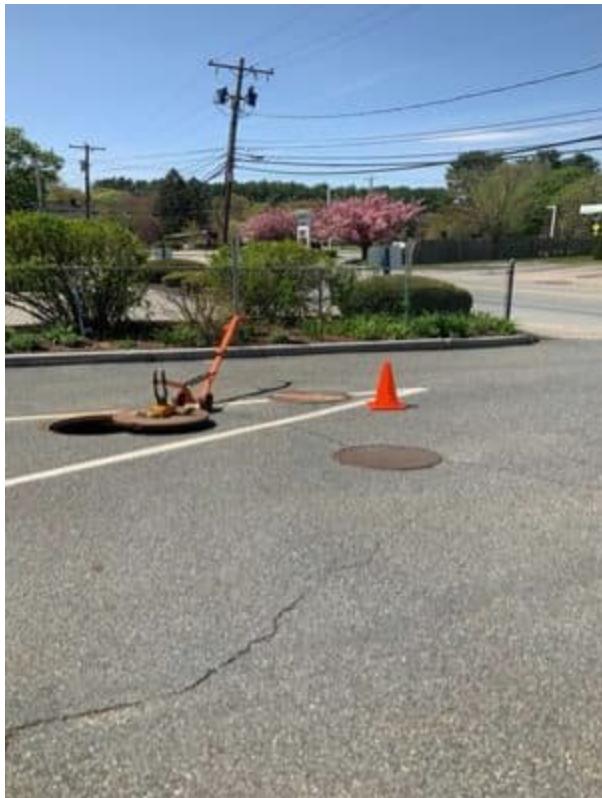
Structure Type:	Subsurface	BMP Type:	Oil-Grit Separator
Structure Material:	Concrete	If "Other":	
Dimensions	Measurement	Additional Notes:	2 manhole chambers. Both inflow pipes for each chamber are plugged but standing water was observed in each. Previous inspection indicated the system is off-line.
Cover/Grate Size	26'		
Cover/Grate Shape	Round		
Structure Diameter	4'

Surface

Problem	Description	Quantity	Completed (by)	Date
Sediment/Debris	Remove sediment and debris to help water discharge			
Grate/Cover	Repair frame and grate

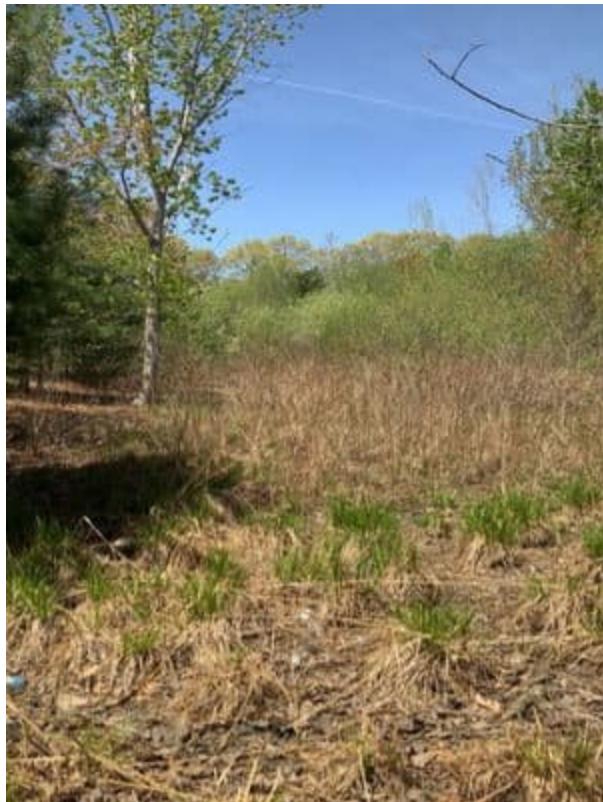
Basin

Problem	Description	Quantity	Completed (by)	Date
Sediment/Debris	Remove trash

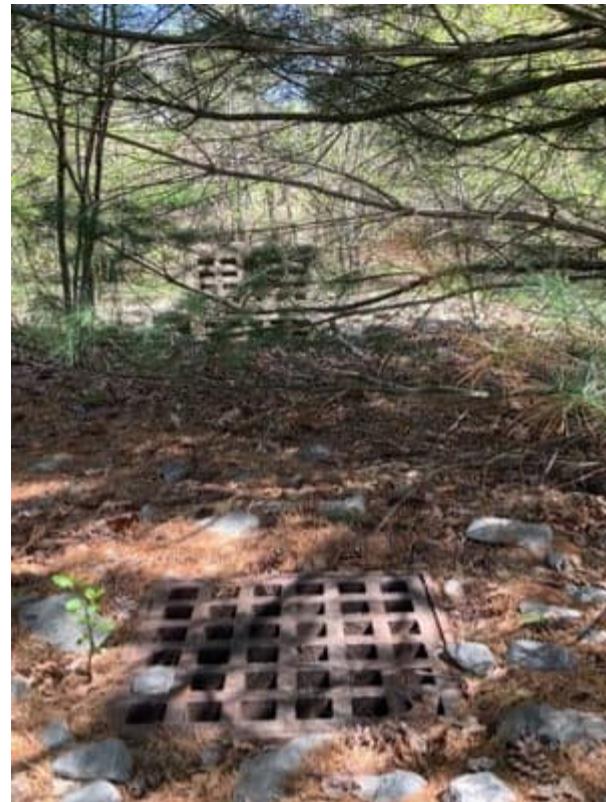
Exit structures

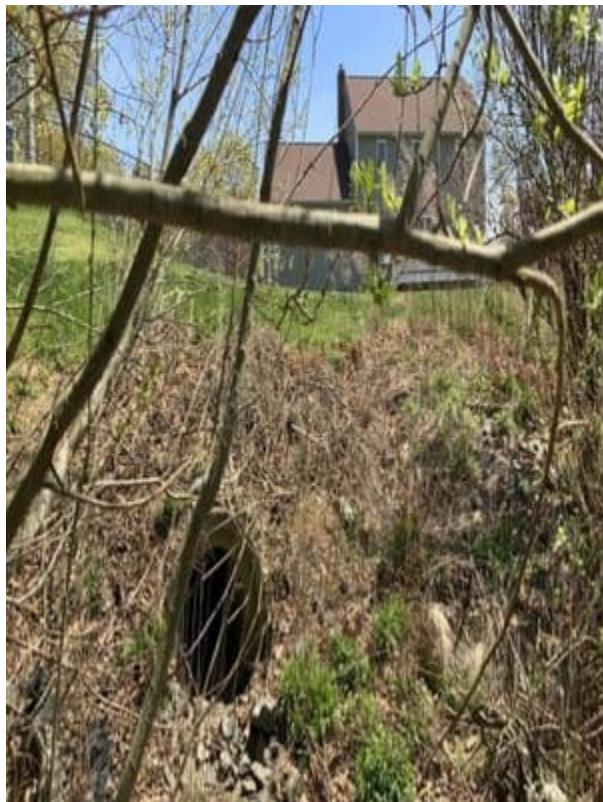
Basin inlet

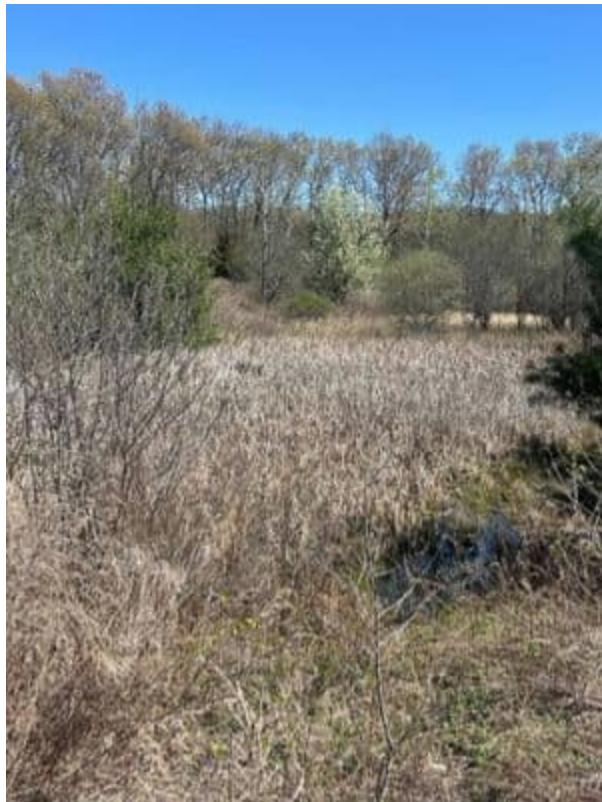
Structure Type:		BMP Type:	
Structure Material:	Vegetated	If "Other":	
Dimensions	Measurement	Additional Notes: Vegetation makes basin difficult to access	
	Length: 320'		
	Top Width: 75'		
	Bottom Width: 55'		
	Depth: 3'

Main Basin area

Problem	Description	Quantity	Completed (by)	Date
	Clean brush and trees from basin and basin inlet

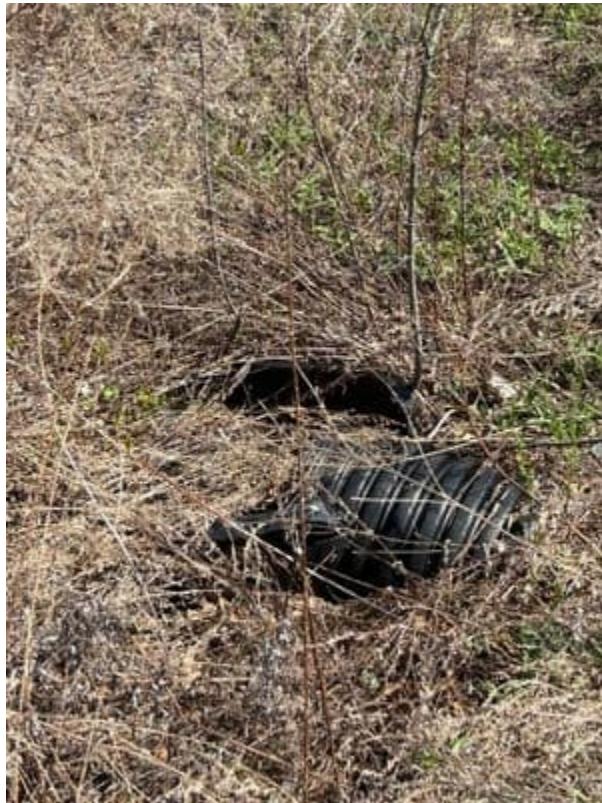
Brush around inlet

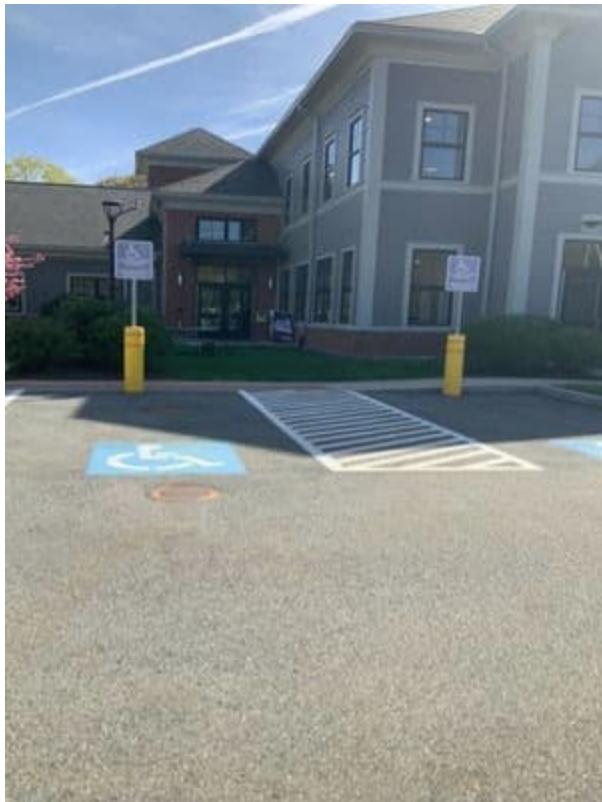
Infiltration system in parking lot with cleanouts

Problem	Description	Quantity	Completed (by)	Date
Sediment/Debris	Remove Sediment and Debris

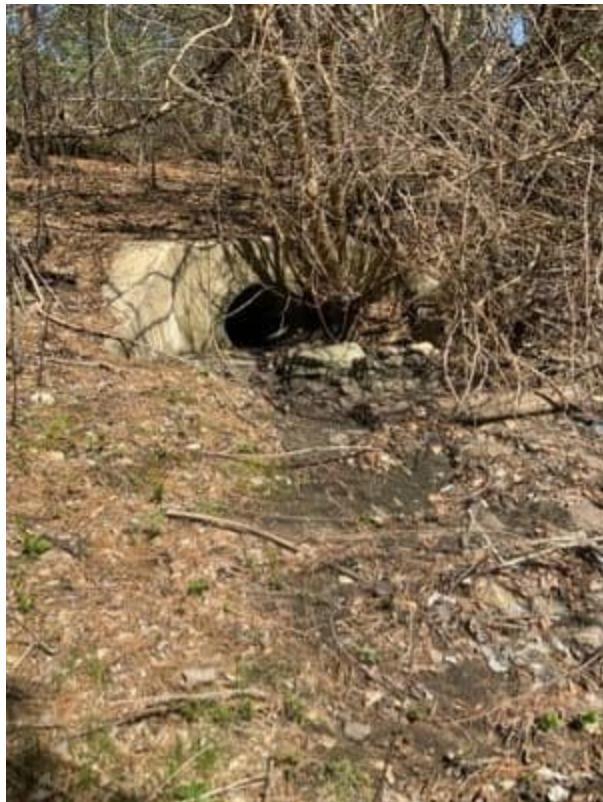
Inlet to detention basin.

Problem	Description	Quantity	Completed (by)	Date
Riprap	Clean up trash and overgrowth of vegetation			
Other	Remove dead trees and brush from main basin area			
Sediment/Debris	Remove sediment, debris, and trash from all catch basins

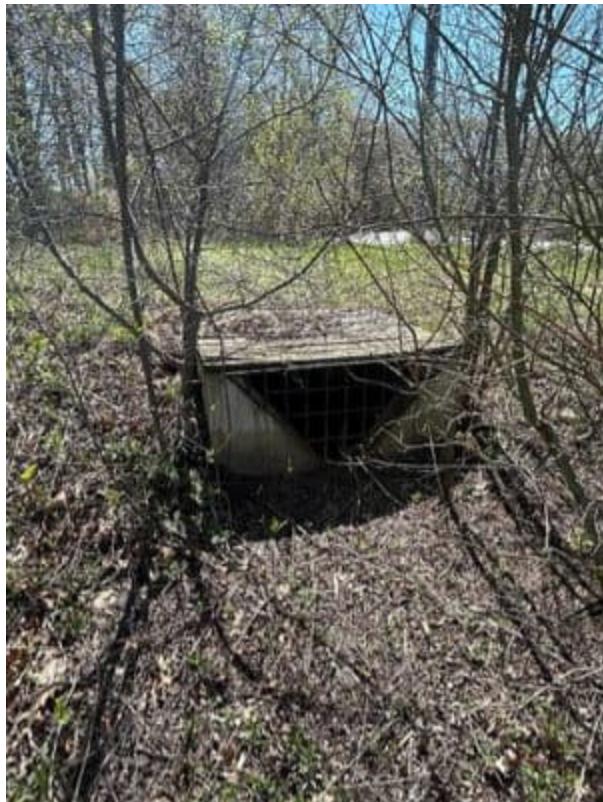
Basin outlet structure

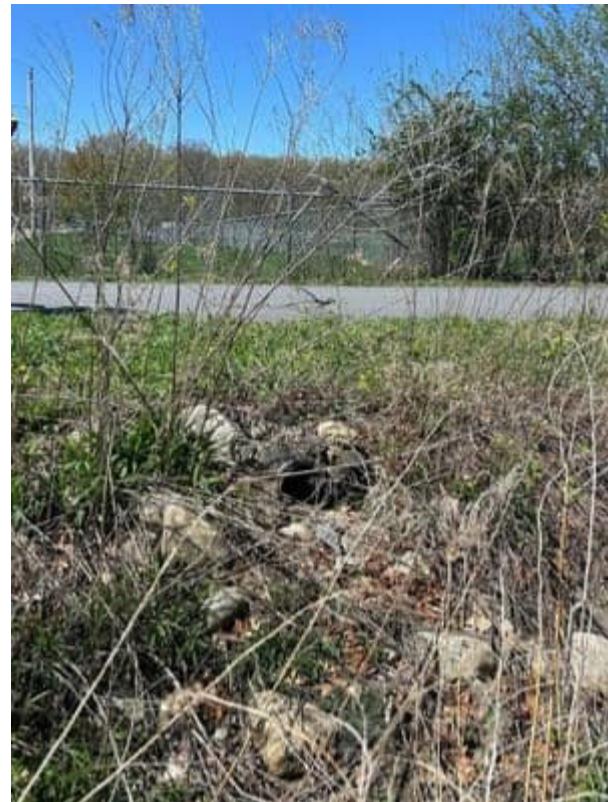
Basin inlet culvert

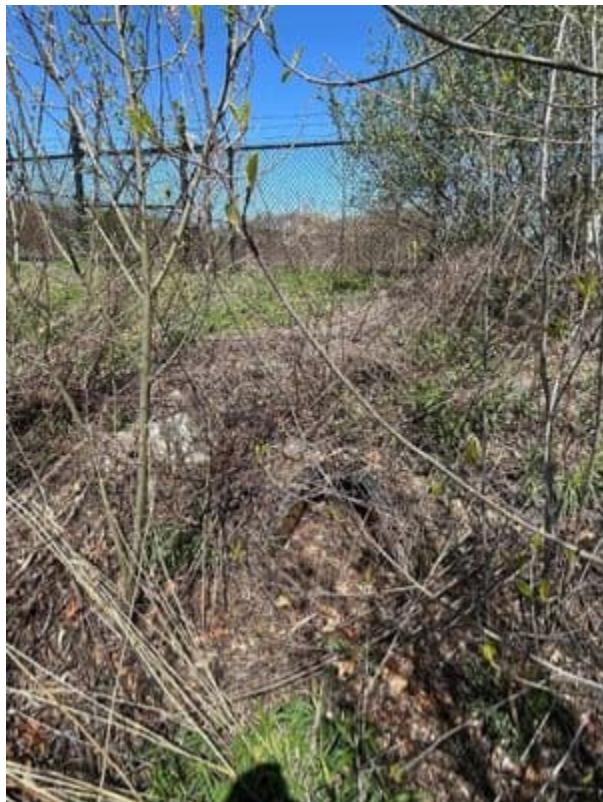
Basin inlet/outfall

Problem	Description	Quantity	Completed (by)	Date
Inlet	Remove brush from basin inlet/outfall

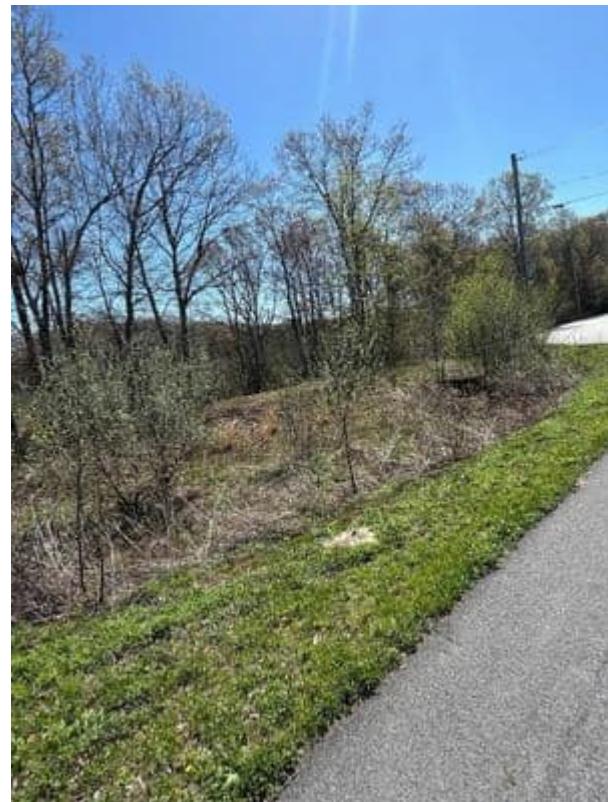
Basin

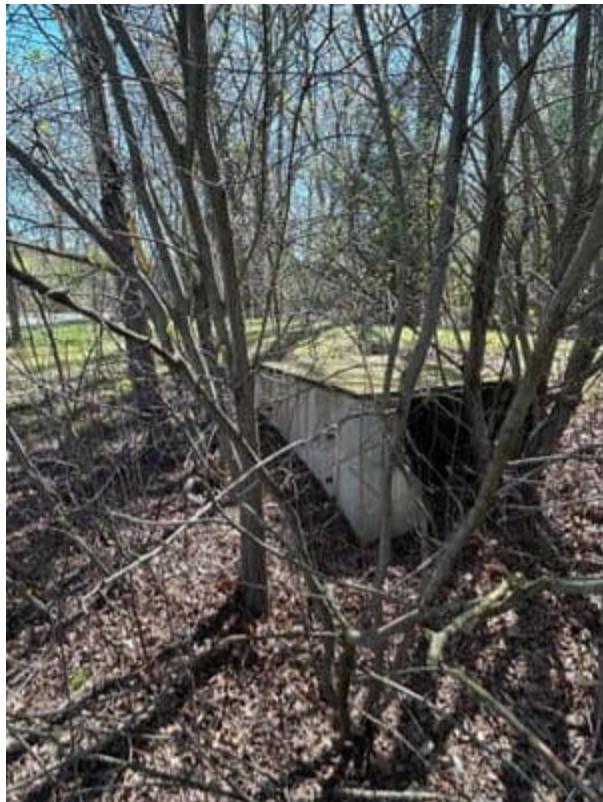
Basin outlet

Problem	Description	Quantity	Completed (by)	Date
Outlet	Remove trees and brush blocking outlet structure opening			
Inlet	Remove brush and trash at basin inlet

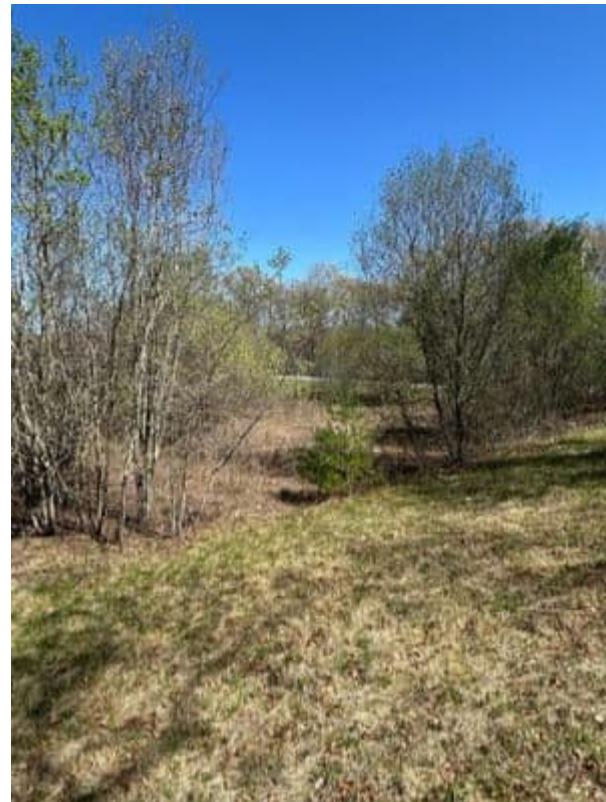
Basin

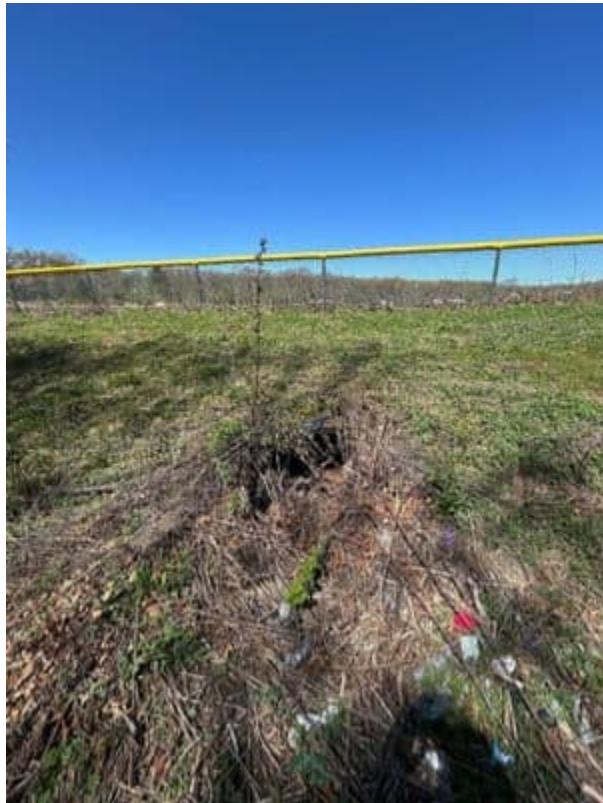
Basin inlet

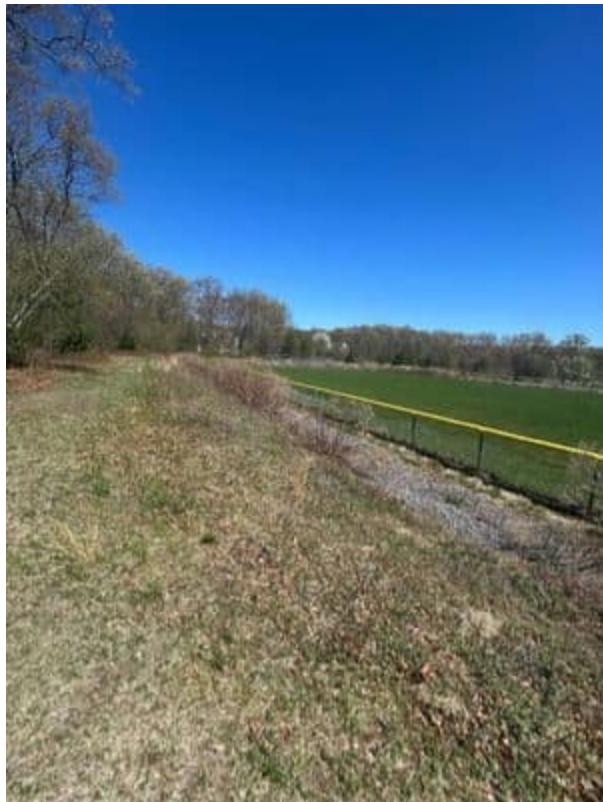
Infiltration Trench

Problem	Description	Quantity	Completed (by)	Date
Vegetation	Clear brush from trench

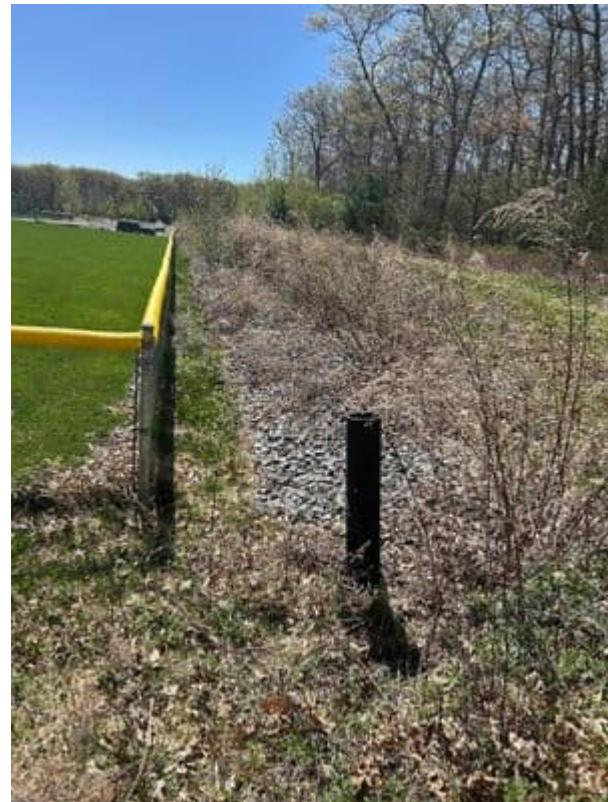
Trench with view port at termination point

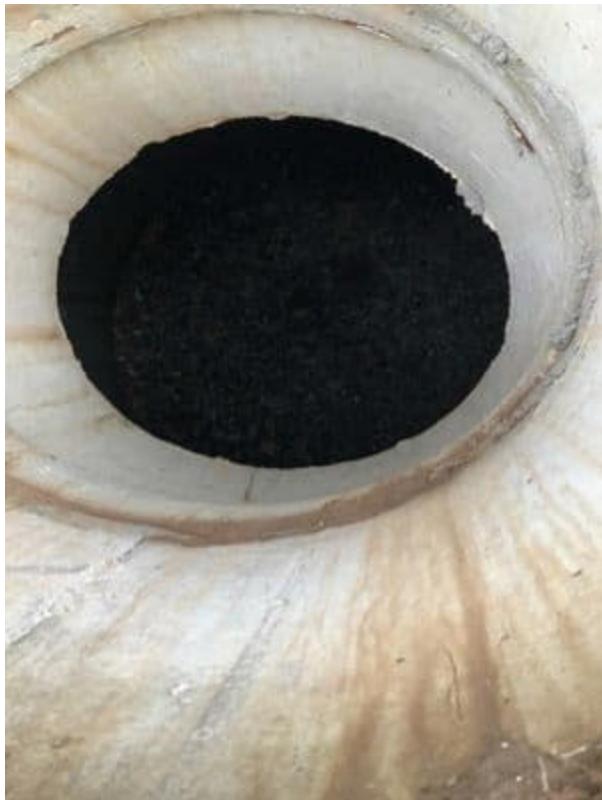
Structure Type:	Subsurface	BMP Type:	Other
Structure Material:	Pre-cast concrete	If "Other":	Leaching Manhole
Dimensions	Measurement	Additional Notes:	Trash found within manhole. (3 LMHS)
Structure Diameter	8 ft		
Structure Depth	8 ft

Inside leaching manhole

Problem	Description	Quantity	Completed (by)	Date
Grate/Cover	Reset frame and grate

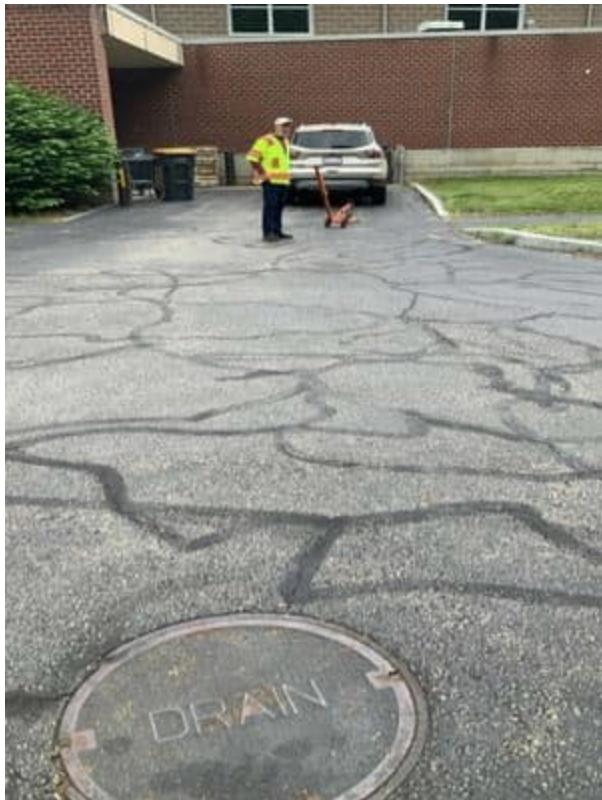
Structure Type:	Subsurface	BMP Type:	Other
Structure Material:	Precast Concrete	If "Other":	Leaching Manholes
Dimensions	Measurement	Additional Notes:	Three leaching manholes connected in series. Confirmed system connects to drainage system on-site through overflow pipe.
Structure Diameter	8 ft		
Structure Depth	6 ft

Leaching Manhole System

Problem	Description	Quantity	Completed (by)	Date
Grate/Cover	Unable to open exit MH

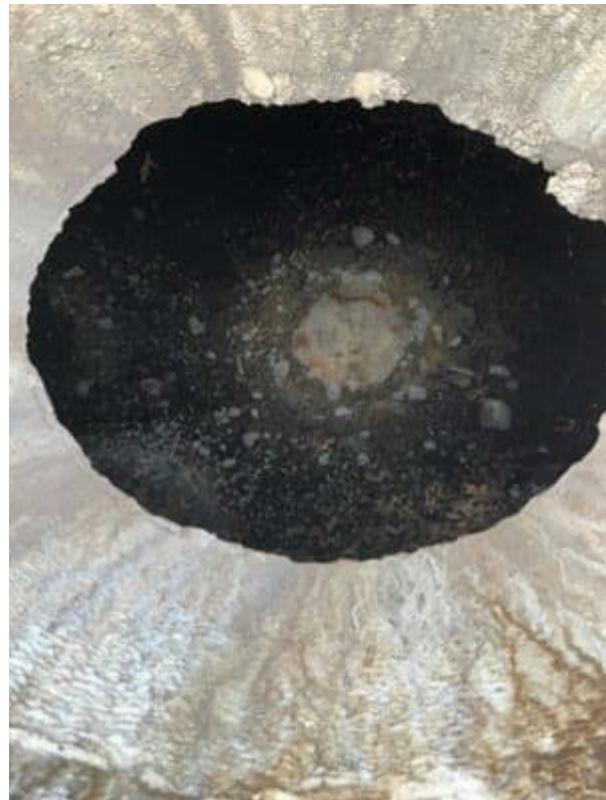
Inside middle manhole

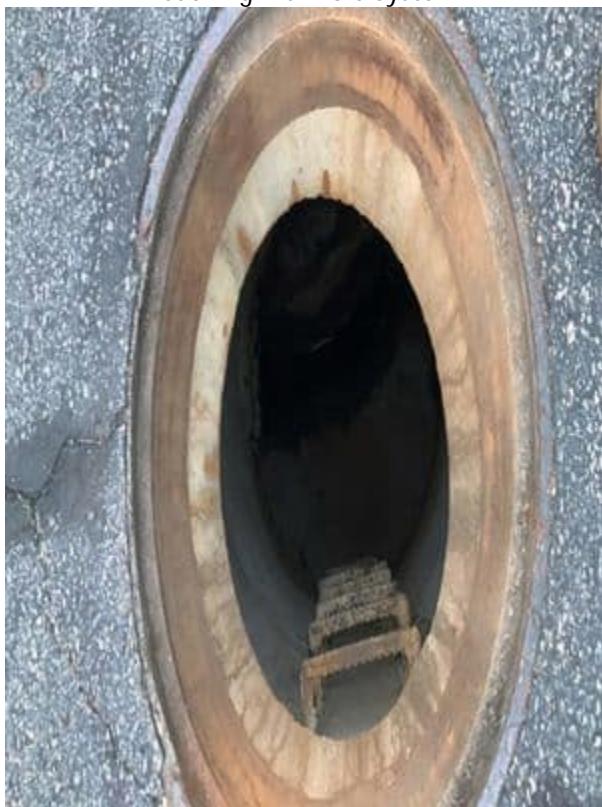
Inside entry mh

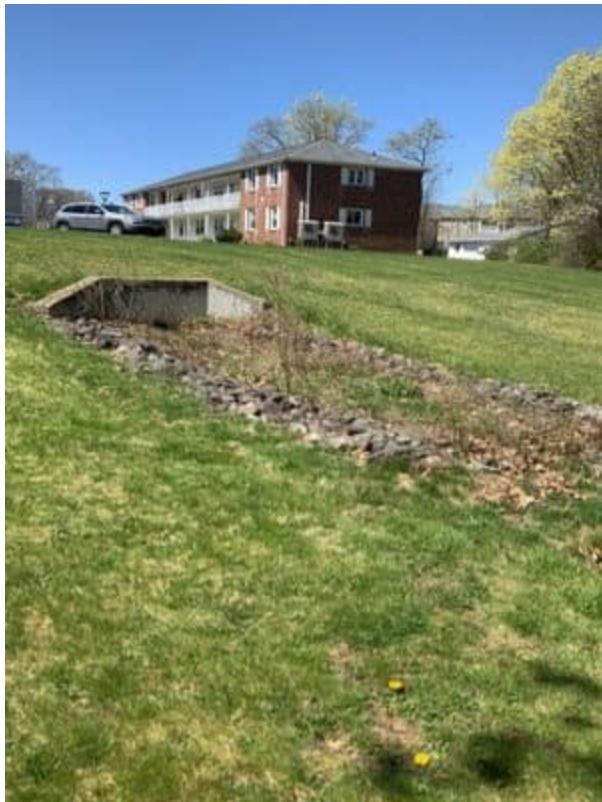
Basin full view

Problem	Description	Quantity	Completed (by)	Date
Sediment/Debris	Remove sediment and minor yard debris at inlet			
Riprap	Extend riprap to wooded area to avoid erosion

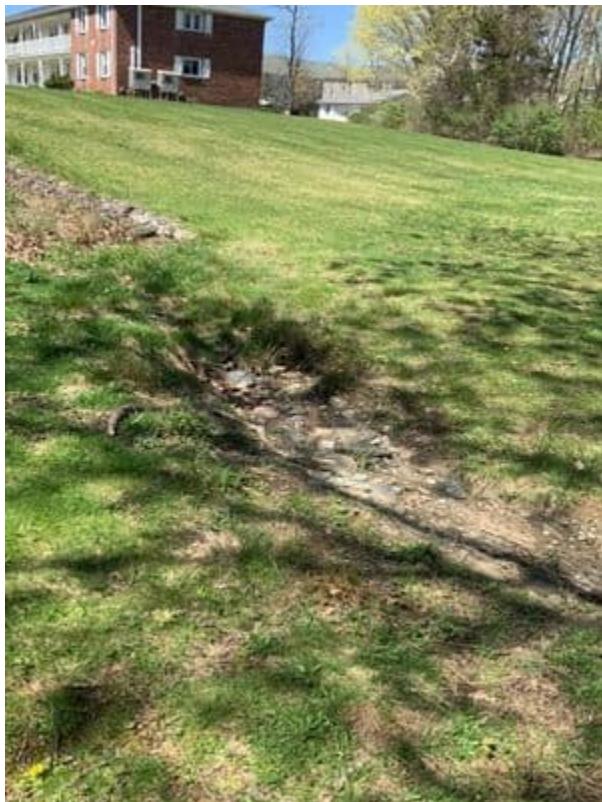
Erosion beyond rip rap channel

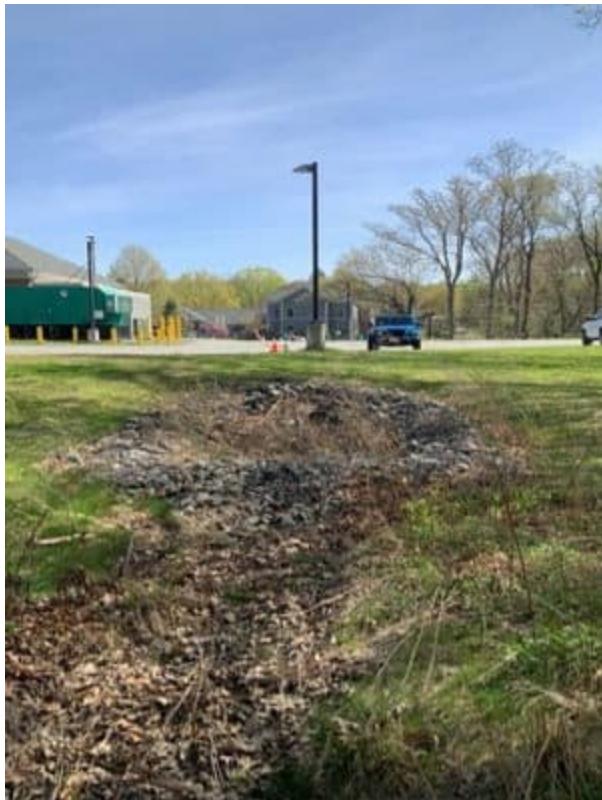
Basin

Problem	Description	Quantity	Completed (by)	Date
Sediment/Debris	Remove sediment and vegetation

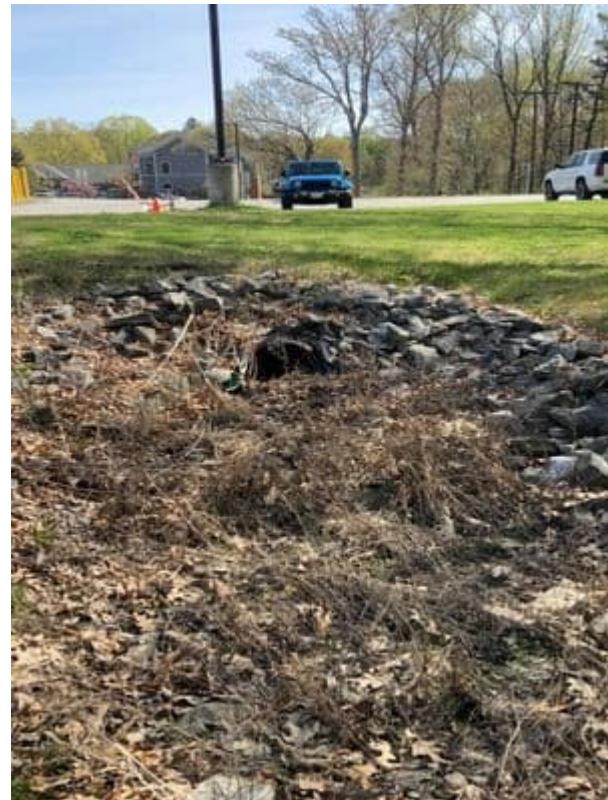
Basin Inlets

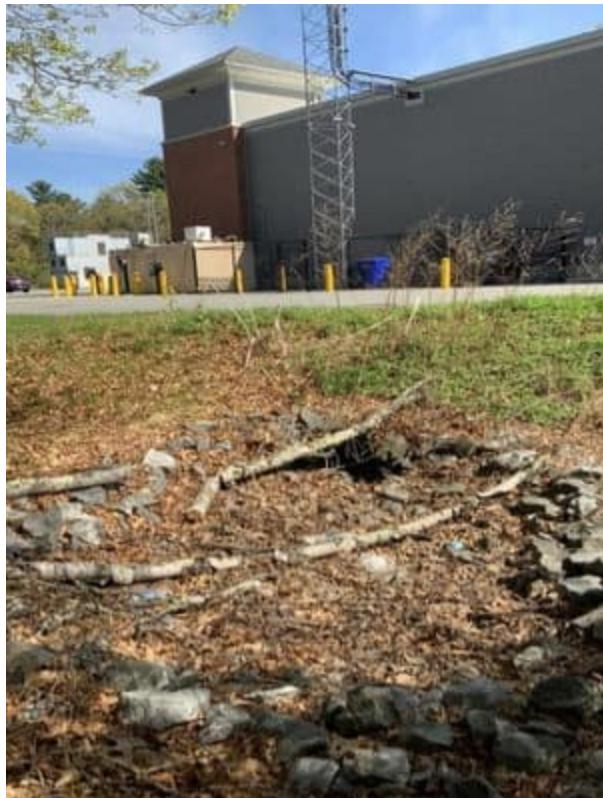
Basin

Problem	Description	Quantity	Completed (by)	Date
Sediment/Debris	Remove sediment and tree debris

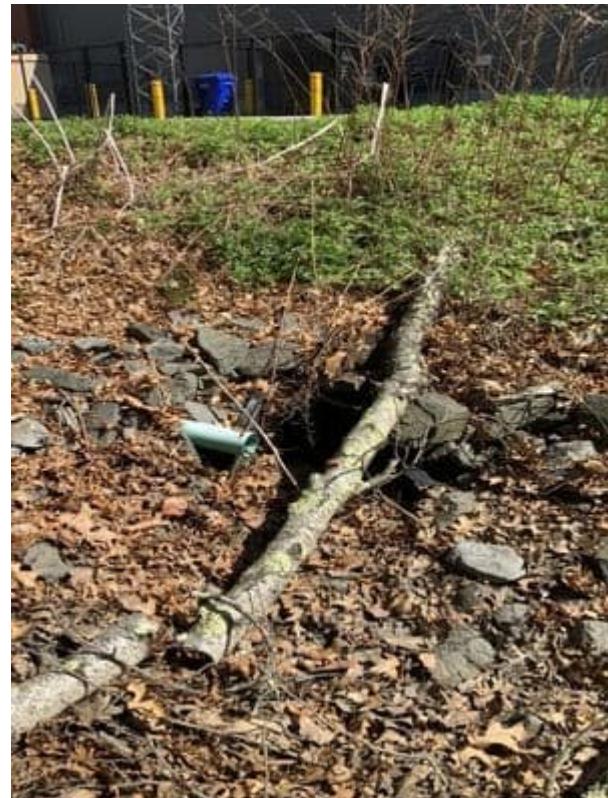
Basin Inlets

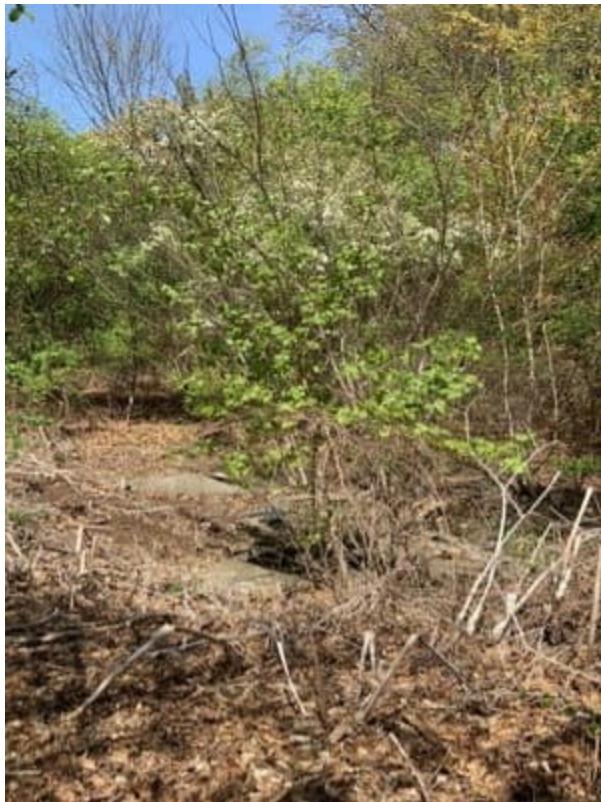
Basin

Problem	Description	Quantity	Completed (by)	Date
Sediment/Debris	Remove vegetation, tree debris, construction debris and trash

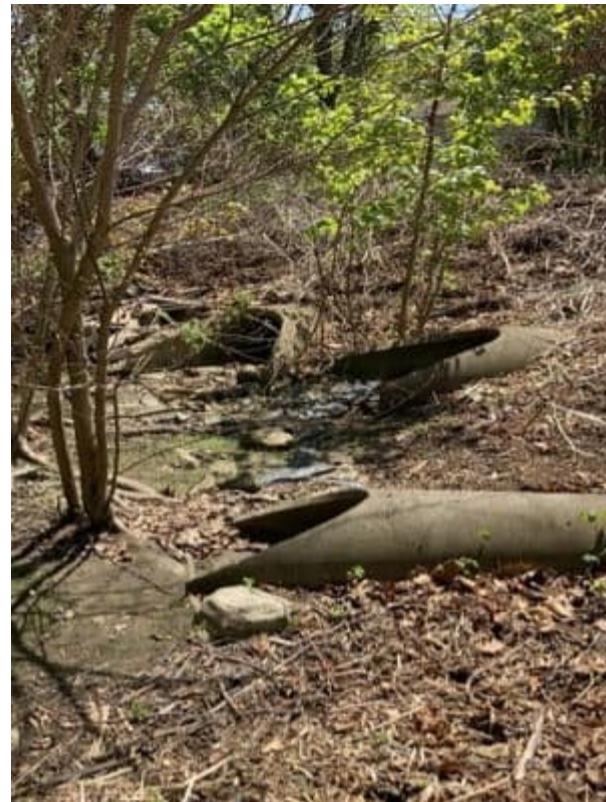
Basin inlets

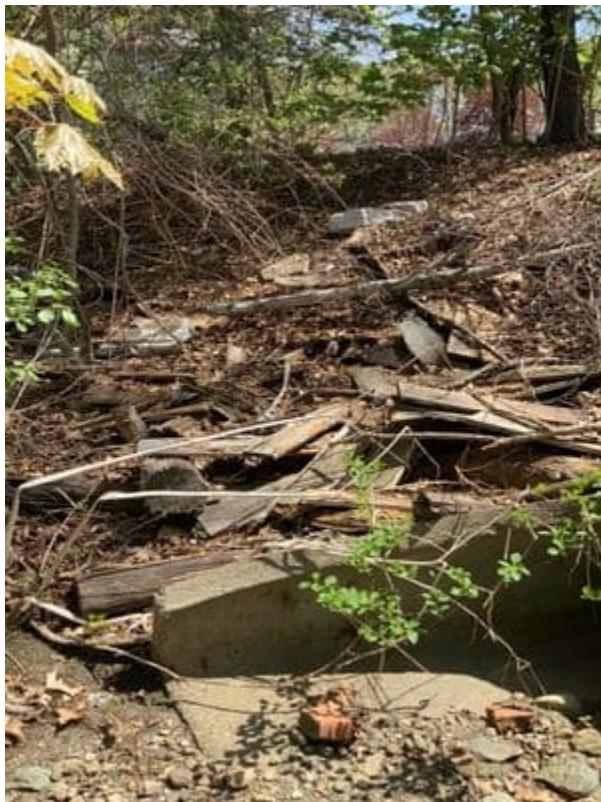
Construction debris

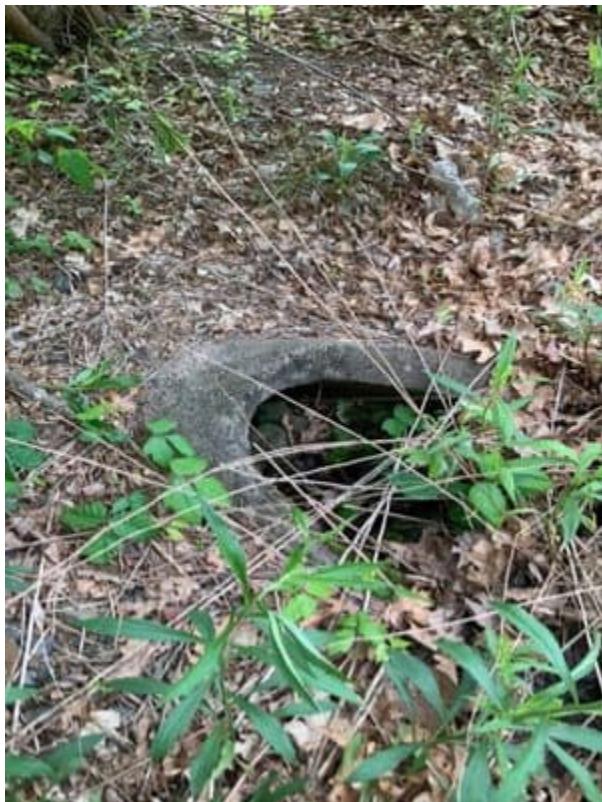
Basin inlet

Problem	Description	Quantity	Completed (by)	Date
Inlet	Unbury basin inlet			
Sediment/Debris	Remove trash in basin

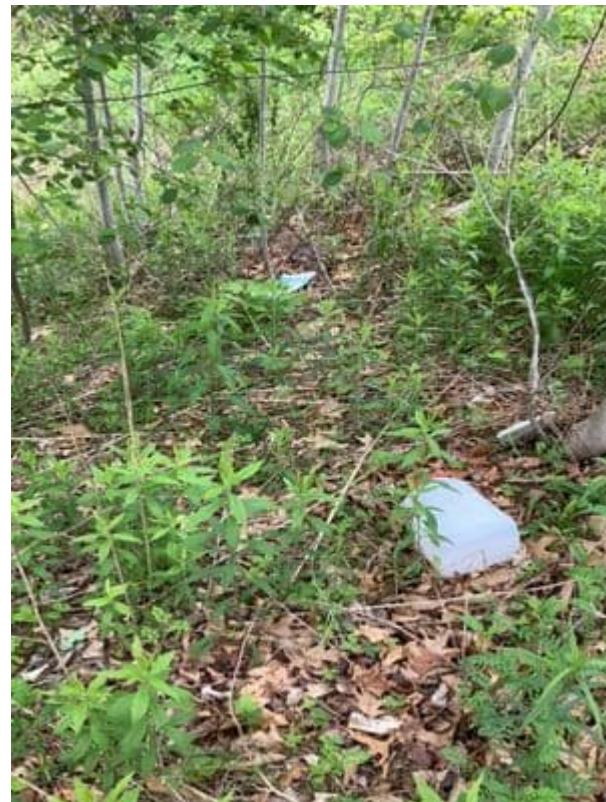
Trash in basin mm

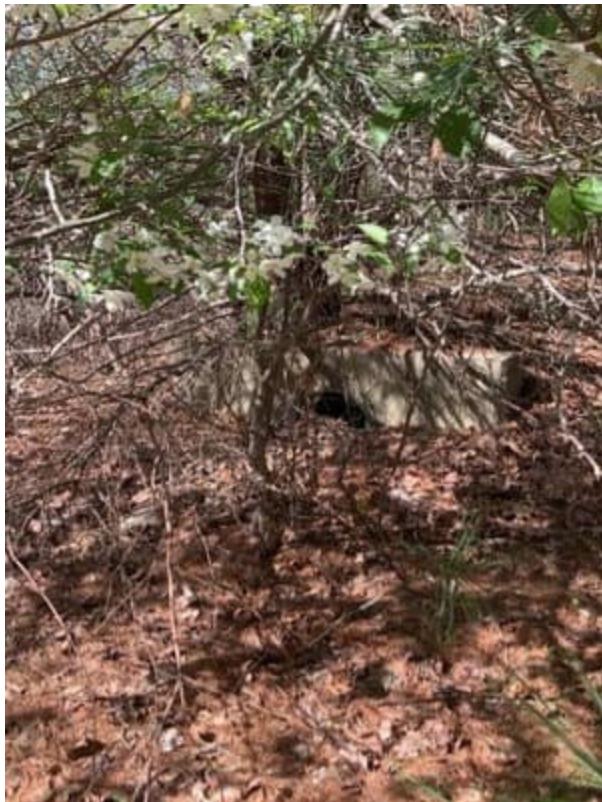
Structure Type:	Surface	BMP Type:	Detention
Structure Material:	Processed stone base	If "Other":	
Dimensions	Measurement	Additional Notes:	Detention basin is full of trash and pet waste bags. Public education is recommended to help mitigate waste from the source. Stormwater enters from the 2 outfalls and infiltrates through X leaching catch basins.
Bottom Width	85 ft		
Top Width	110 ft		
Depth	6 ft

Stormwater Outfall #1 from Landau Road

Problem	Description	Quantity	Completed (by)	Date
Inlet	Remove trash and pet waste from outfalls	-		
Sediment/Debris	Remove trash, leaves, and debris throughout basin

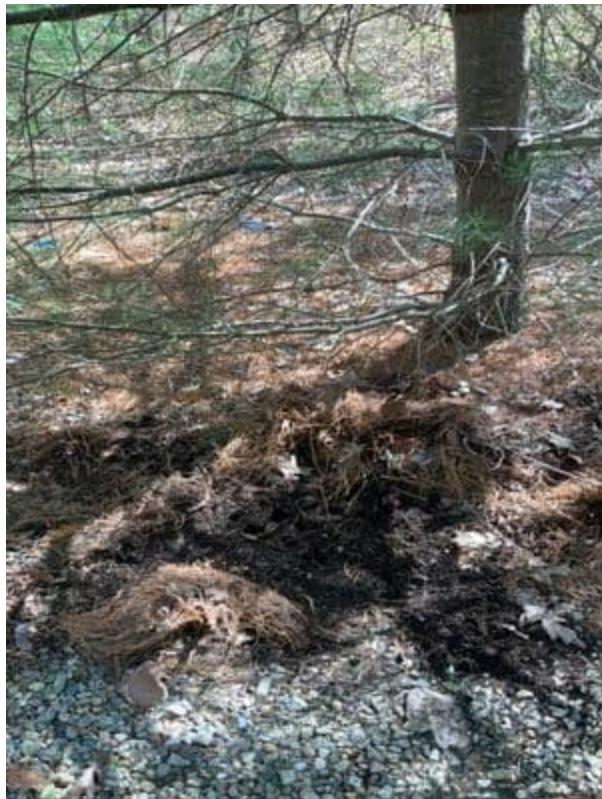
Leaching Catch Basins covered with leaves and debris.

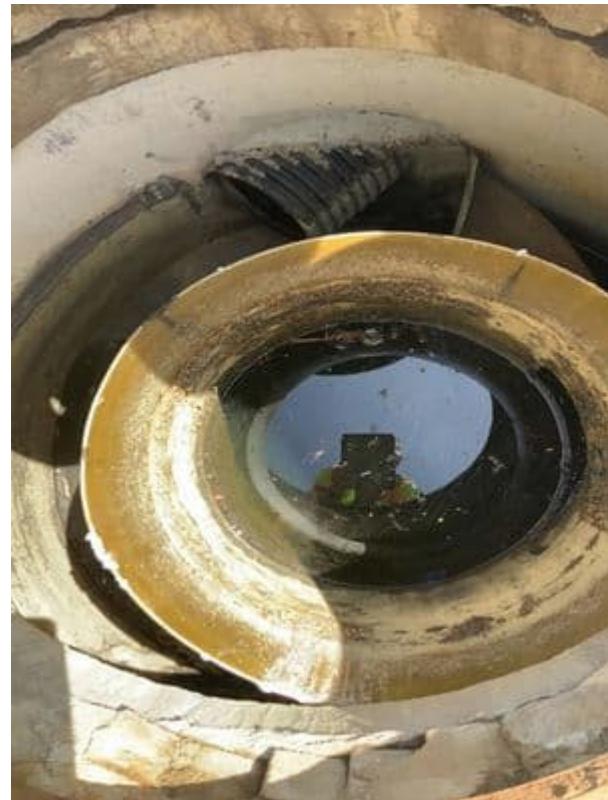
Inside

Problem	Description	Quantity	Completed (by)	Date
Sediment/Debris	Remove sediment and debris

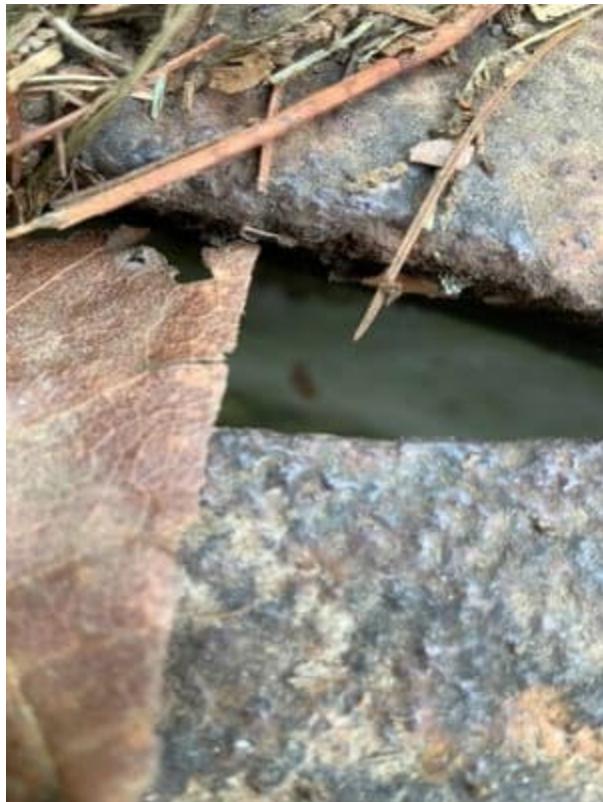
Structure Type:	Subsurface	BMP Type:	Leaching CB
Structure Material:	Pre-cast concrete	If "Other":	
Dimensions	Measurement	Additional Notes:	Moderate yard waste observed within catch basin.
Structure Diameter	8 ft		
Structure Depth	5 ft

Leaching catch basin

Problem	Description	Quantity	Completed (by)	Date
Sediment/Debris	Clean out leaf debris

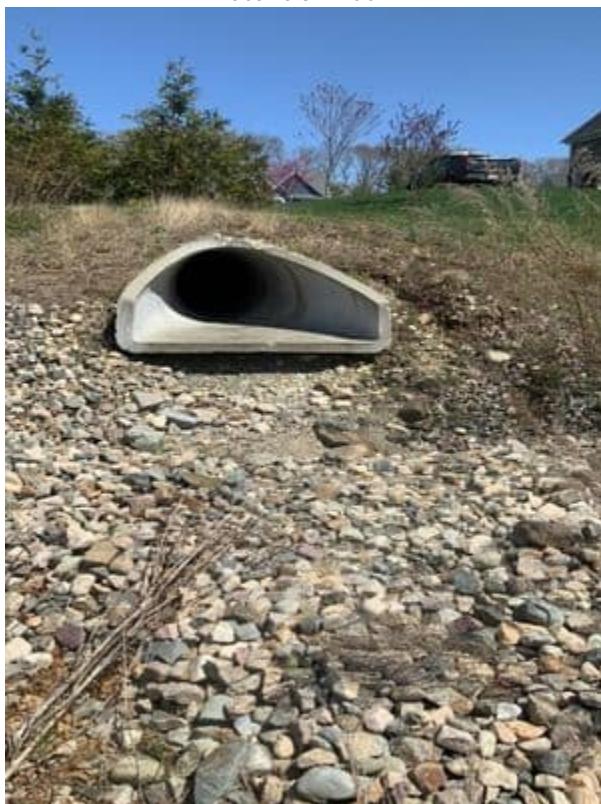
Erosion at 30" outfall into basin

Problem	Description	Quantity	Completed (by)	Date
Erosion	Erosion at 30" outfall. Add rip rap

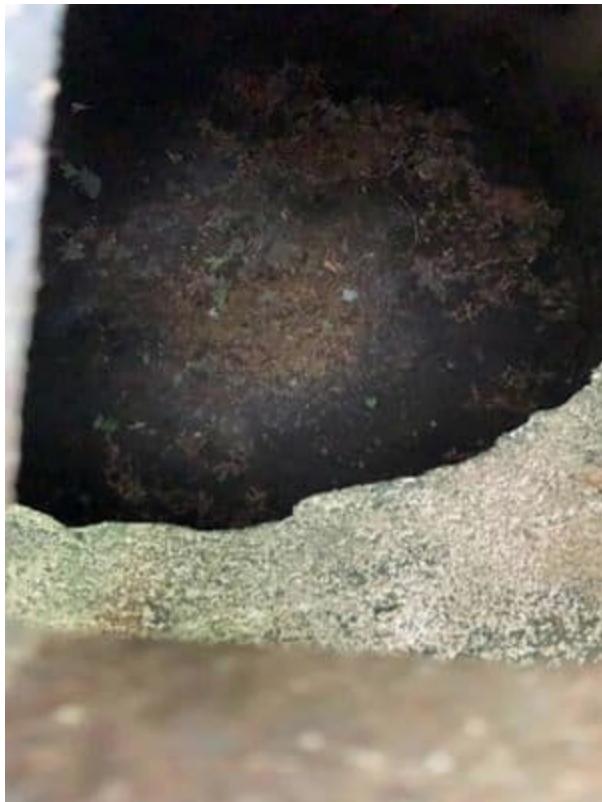
Structure Type:	Subsurface	BMP Type:	Leaching CB
Structure Material:	Pre-cast concrete	If "Other":	
Dimensions	Measurement	Additional Notes:	Remove sediment and debris found at grate cover.
Structure Depth	7 ft		
Structure Diameter	6 ft

Interior of leaching catch basin

Problem	Description	Quantity	Completed (by)	Date
Sediment/Debris	Remove sediment and debris located around CB

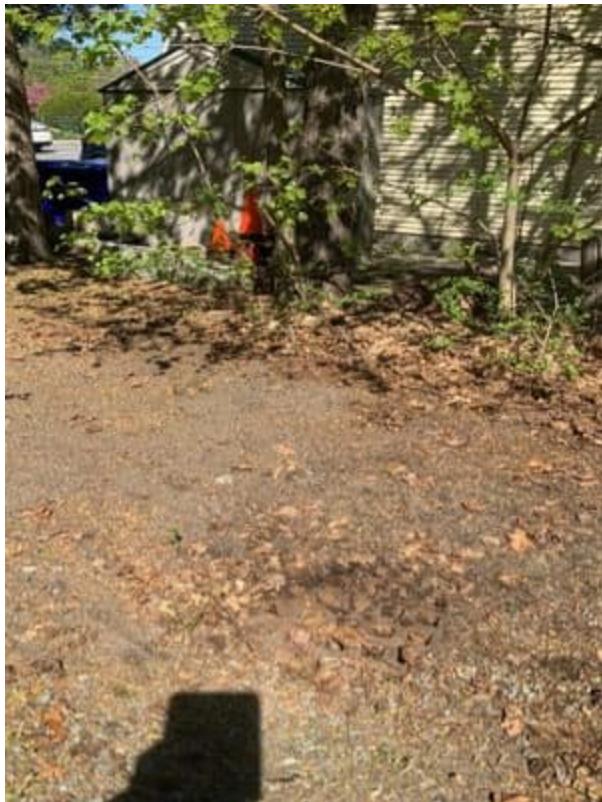
Outside CB. Full of debris

Problem	Description	Quantity	Completed (by)	Date
Grate/Cover	Remove leaves and debris from grate and remove sediment and debris from catch basin interior

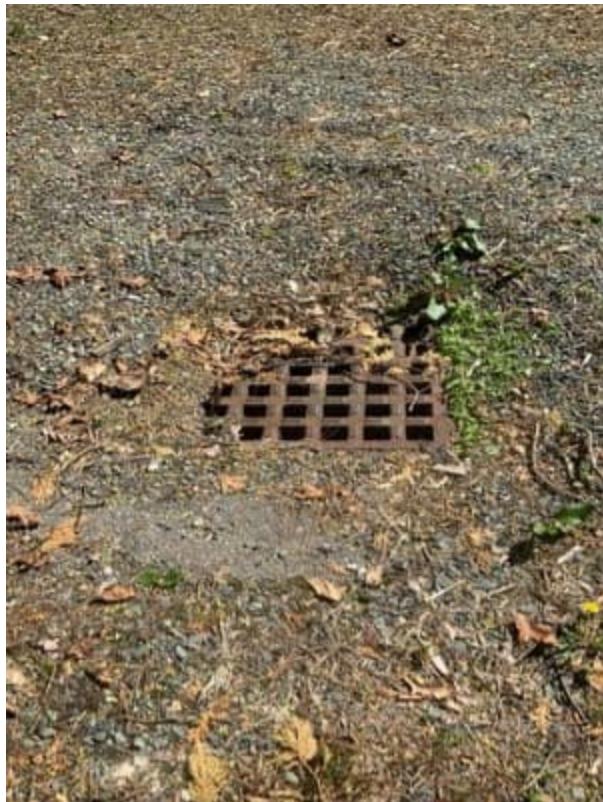
Leaching Catch Basin. Covered in leaves and debris

Problem	Description	Quantity	Completed (by)	Date
Sediment/Debris	Remove sediment and leaves from grate and interior	1 ft of sediment

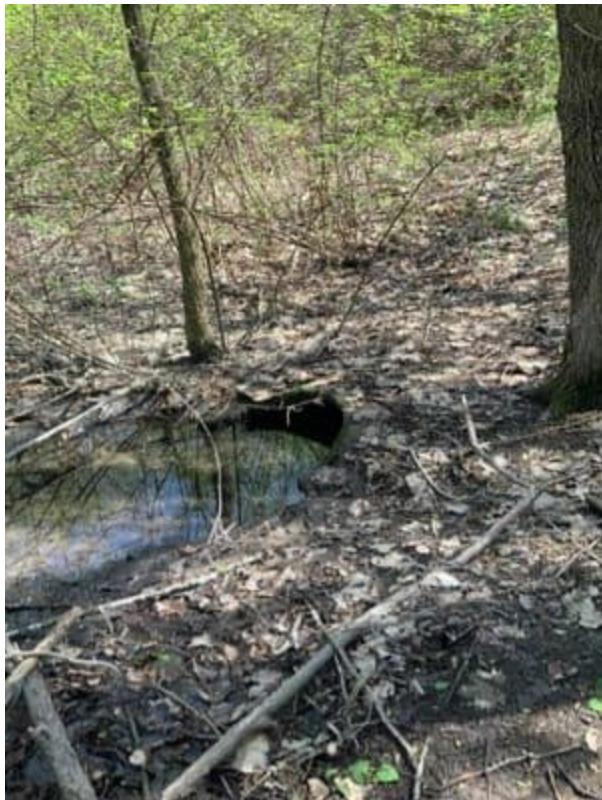
Structure Type:		BMP Type:	
Structure Material:		If "Other":	
Dimensions	Measurement	Additional Notes:	Sediment blocking inlet pipe

Basin Inlet

Problem	Description	Quantity	Completed (by)	Date
Inlet	Clean sediment from basin inlet pipe
