PARKS AND OPEN SPACE & BUILDINGS AND FACILITIES						
Facility ID	Address	Inspector	Inspection	Maintenance Required?	Notes	Facility Maintenance
Athletic League Field (F-1)	COWELL LAND	Bob Lamoureux	4/28/2025	No		
Boy Scouts of America 132 (F-2)	24 SPRING ST	Bob Lamoureux	4/28/2025	Yes		Stone Chip Driveway: Repair erosion at driveway entrance
Council on Aging (F-3)	24 SPRING ST	Bob Lamoureux	4/28/2025	No		
Field of Dreams (F-4)	78 SCHOOL ST	Bob Lamoureux	4/28/2025	Yes		Stone chip driveway at catch basin: Reroute erosion around catch basin in-front of practice baseball field. Stone trench: Cut brush along trench
Former Police/Fire (F-5)	157 SOUTH ST	Bob Lamoureux	4/28/2025	Yes		Catch Basin and Access road: Clean debris around catch basin and sweep access roadway around building Access Road: Sweep access road around building

BMP #	Record Plan	Facility Name	Location	BMP/Feature Description	Inspection Date	Recommended Maintenance	Action Taken
BMP-1	No	Roadway Stormwater Management System	68 Messenger Street	BMP-1: Detention Basin	5/21/2025	None	
BMP-2	No	Roadway Stormwater Management System	2 Maple Terrace	BMP-2: Detention Basin	5/1/2025	None	
BMP-3	No	Roadway Stormwater Management Sys

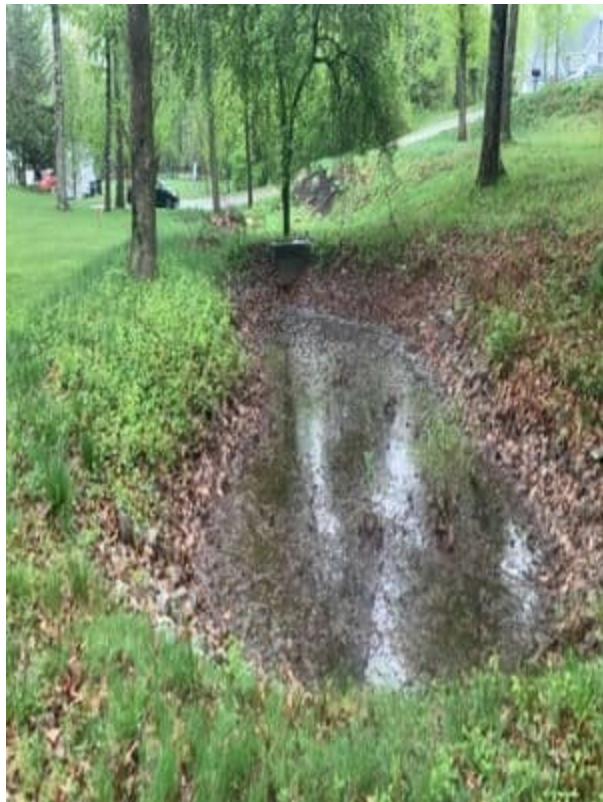
Basin

Problem	Description	Quantity	Completed (by)	Date
Sediment/Debris	Clean sediment from basin

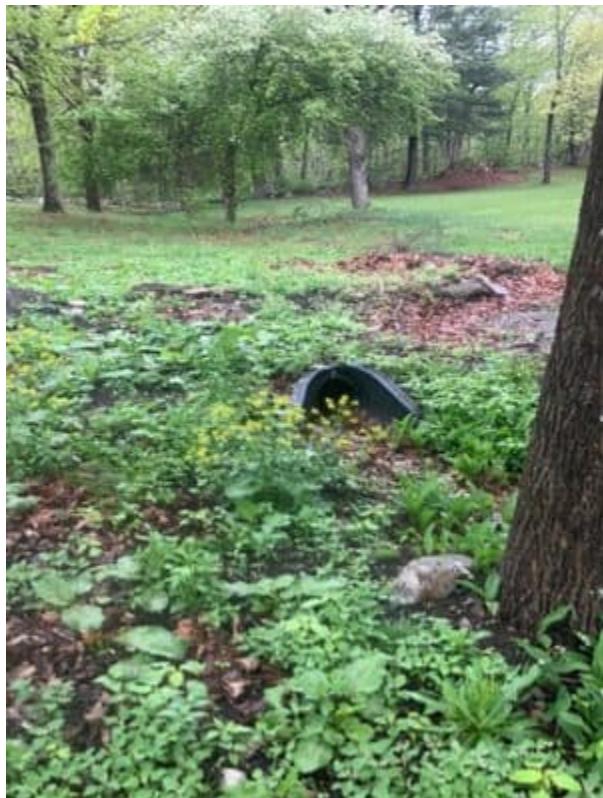
End of basin outlet overland flow to inlet at edge of road

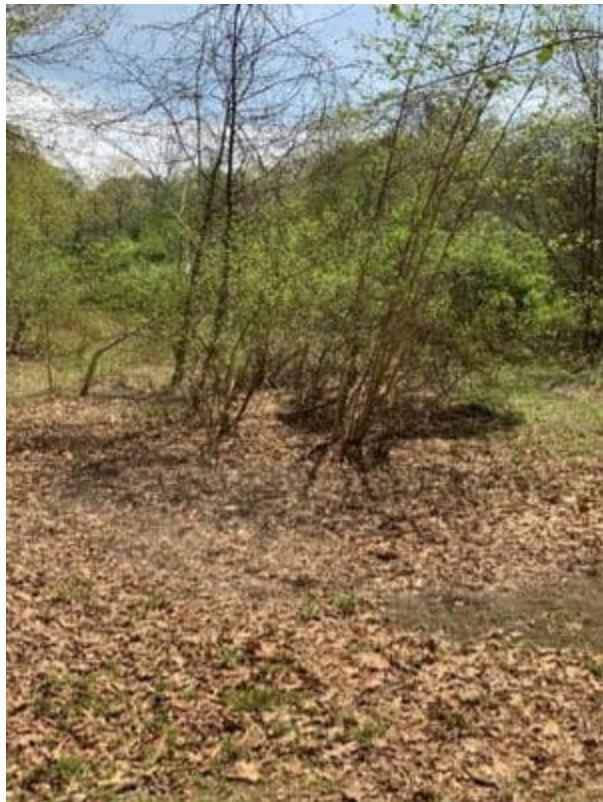
Basin

Problem	Description	Quantity	Completed (by)	Date
Sediment/Debris	Clear sediment from inlet pipe			
Erosion	Erosion throughout basin due to motorized vehicles
